# ***Locker Inspection Services LLC***

## **Property Inspection Report**

**1234 Locker Ln, East Grand Rapids, MI 49506**

**Date of Inspection: 6/26/2023 Time: 9:00 AM**

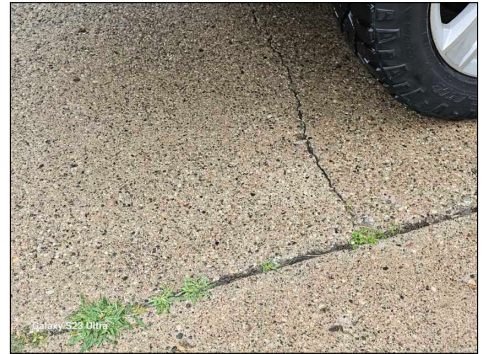
1.1. The driveway has common cracks and will need regular maintenance such as patching and sealing cracks.

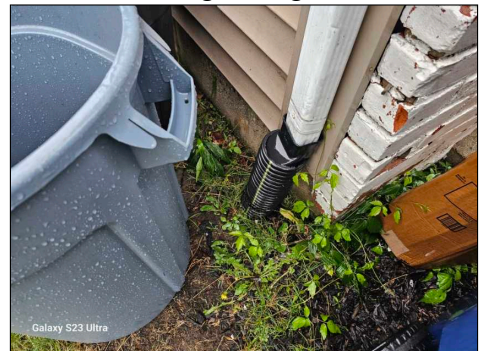
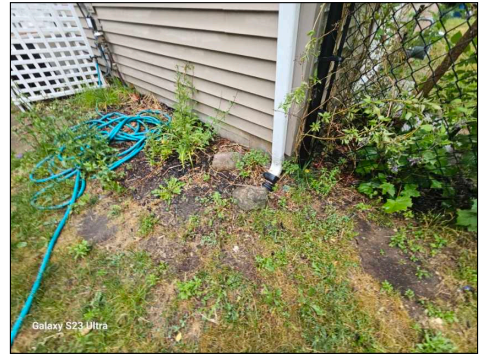
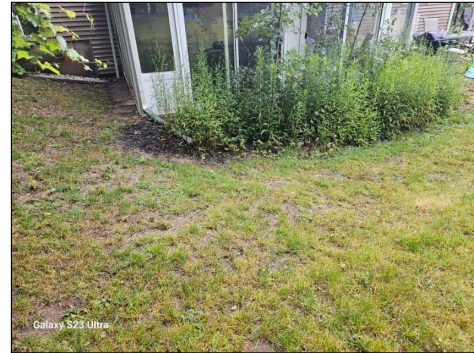
2.1. There is a negative slope at multiple areas around the home. This may allow water to pool against the foundation. Recommend regrading the area.

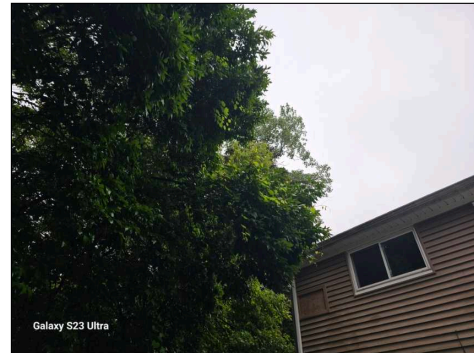
3.1. Overhanging tree branches noted over the roof. Monitor and trim as necessary.

3.2. Tree branches noted rubbing on the siding. Trim as needed to help prevent siding damage.

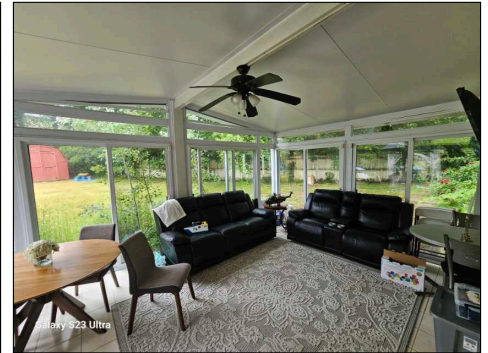
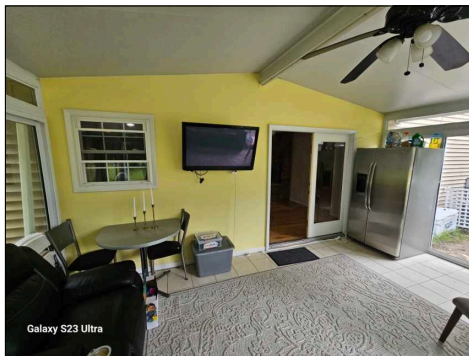
4.1. Posts are loose at the base on the porch at the front of the home. A repair is recommended.

4.2. The porch has common cracks and will need regular maintenance such as patching and sealing cracks.

4.3. Signs of past moisture intrusion noted at the back porch/sun room. No active leaks were noted at the time of inspection, recommend monitoring and repairing as needed.

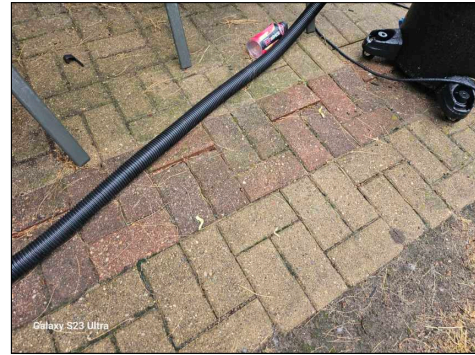
5.1. The patio at the back of the home has common cracks present.

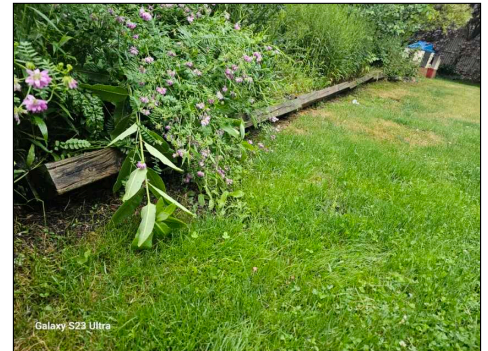
6.3. The retaining wall at the back of the home is failing as evidenced by cracks and/or structural displacement.

Wall failing ext rear

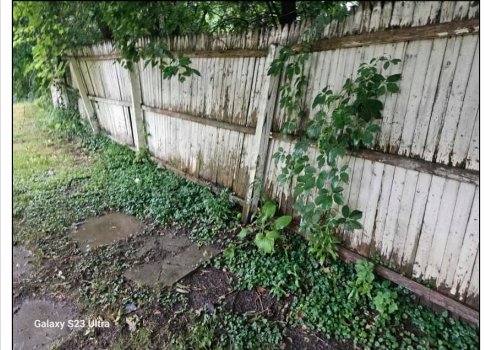
7.1. The fence/fence posts at multiple areas around the home are damaged/deteriorated.

7.2. One section of fence was loose/leaning at the back of the home. Recommend repair/replace as needed.

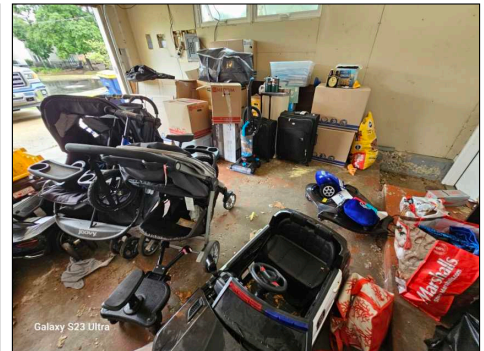
8.1. The garage floor has common cracking present. Seal and preserve as necessary.

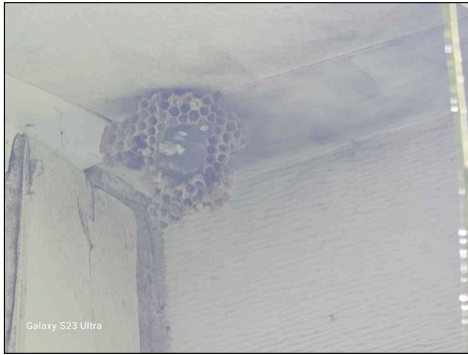
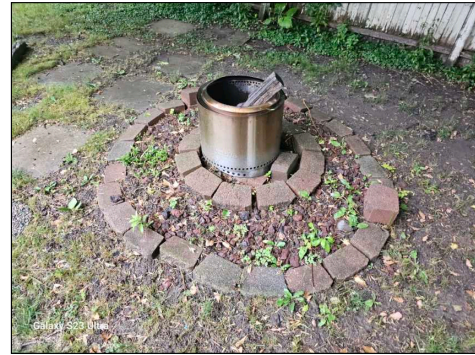
9.1. Hornet or other stinging insect nests noted at the back of the home. Have these professionally removed.

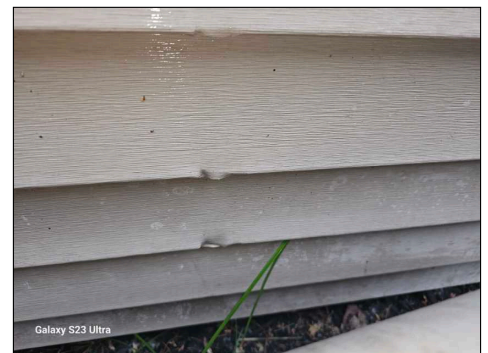
1.6. The brick siding at the exterior front side is pulling away from the home. A repair is recommended by a qualified masonry professional.

Pulling away exterior front side.

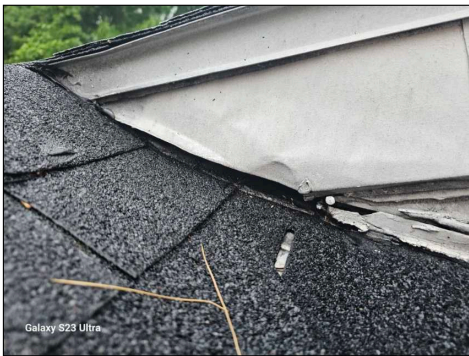
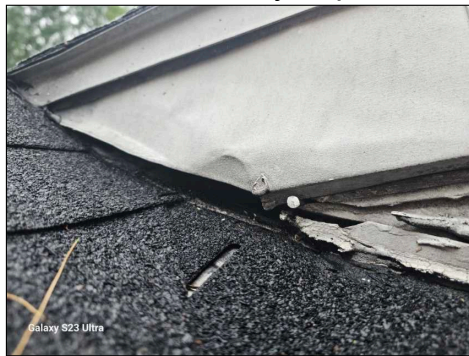
2.1. Damage noted to the fascia and/or soffit near the chimney. Recommend monitoring and repairing as necessary.

2.2. Moisture staining noted on the soffit/fascia at the back of the home. This may indicate the presence of moisture behind finished surfaces. Recommend further evaluation/correction by a qualified contractor.

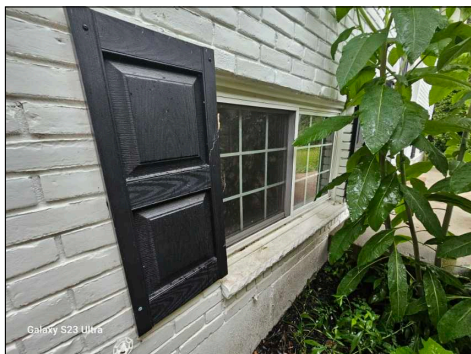
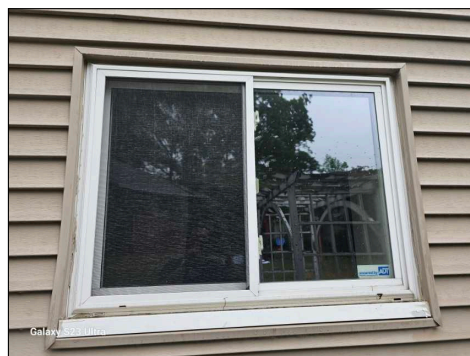
4.1. Cracked / deteriorated caulking noted at one or more exterior windows.  
Repair / maintain as required.

4.2. Loose shutters noted at one or more exterior areas—repair/properly  
secure as needed.

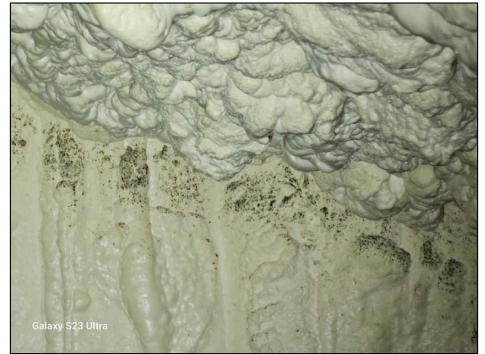
6.1. Potential microbial growth noted at one location. No testing was done to determine if this is a health hazard. We suggest further testing by Locker Inspection Services and cleaning with distilled white vinegar.

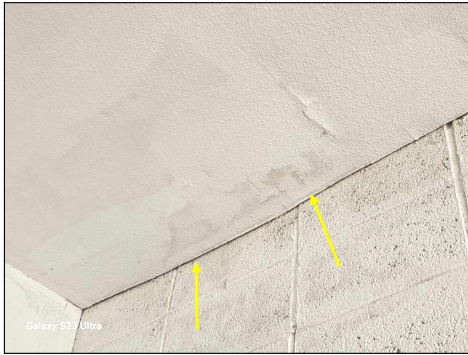
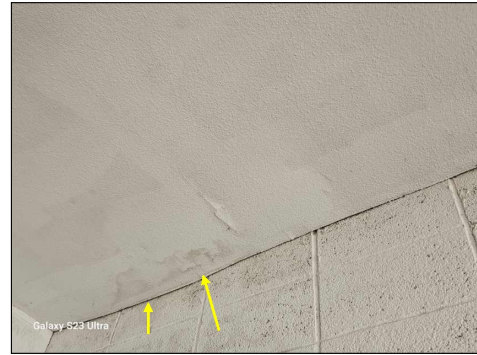
7.1. Signs of past leaking noted in one location. Recommend having the sellers provide documentation of past repairs. No active leaks were noted at the time of inspection.

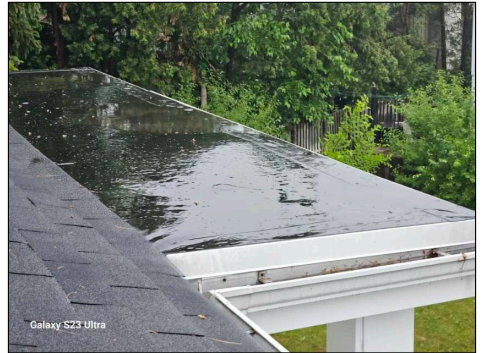
Deviation noted front side

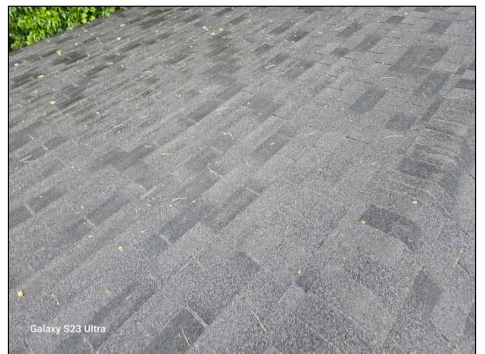
2.4. Shingle tabs are torn off and missing at the exterior rear. Repairs are needed by a qualified roofer.

Missing tab noted rear

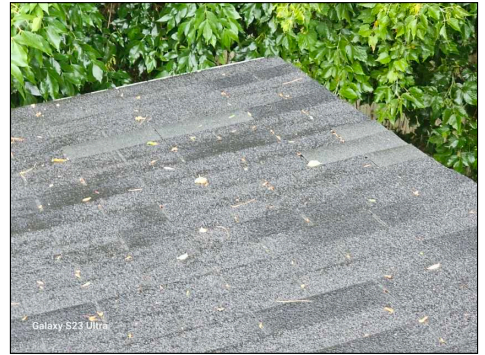
2.5. There are areas with previous repairs noted at the the back . Repairs appear to be serviceable. Recommend monitoring and repairing as necessary.

Previous repairs noted at the rear

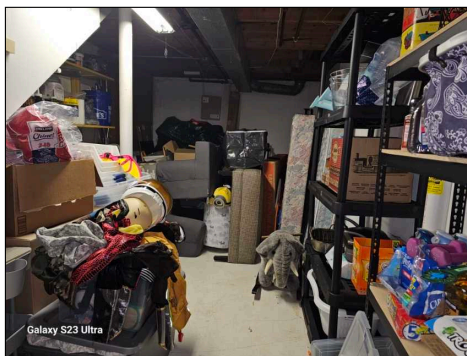
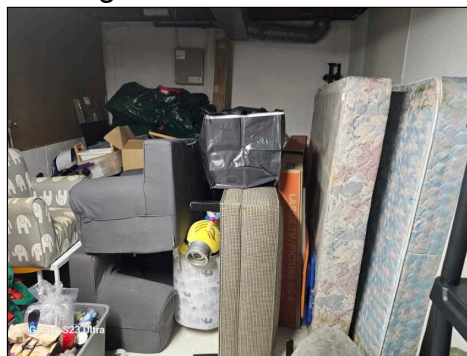
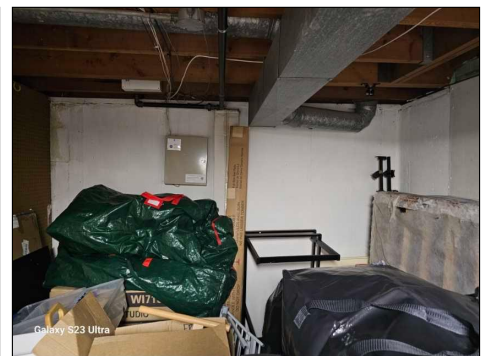
2.1. Common cracks observed in the foundation walls. Monitor for expansion and repair as necessary.

2.2. Previous repairs observed on the foundation walls. Repairs appear serviceable. Obtain any warranties or receipts that may apply and monitor for additional cracking.

Previous repair noted storage room

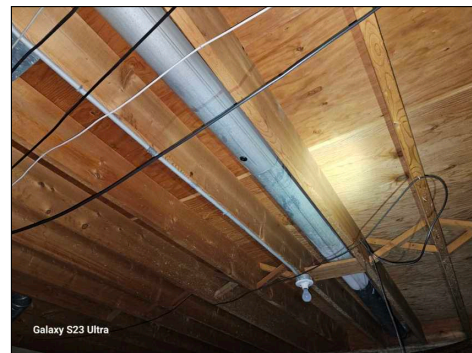
Sealed register/previous repairs noted  
at the sub-flooring

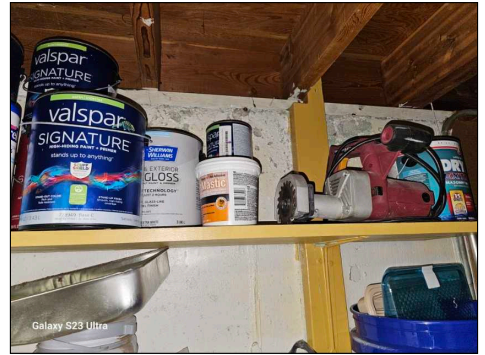
8.1. Efflorescence is a crystalline deposit of salts that can form when water is present in or on concrete. This is noted at the basement foundation walls, although this is usually a harmless phenomenon, this does indicate moisture intrusion. We cannot determine if the moisture entry has stopped or if it is ongoing. Refer to the seller's disclosure and have the cracks professionally evaluated and sealed as necessary.

8.2. Water entry observed in the crawlspace at the left side foundation wall. Recommend all entry points be sealed, ensure all grading slopes away from the property, and all gutters and downspouts properly divert water away from the foundation.

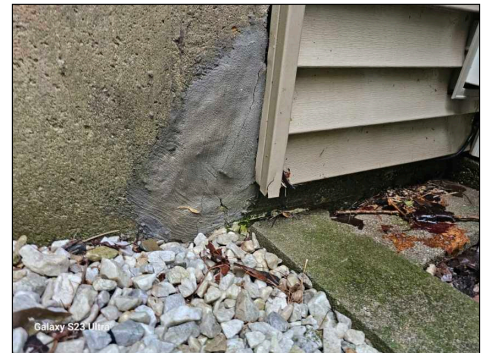
9.2. Past repairs noted on the foundation at the back of the home. Repairs appear to be serviceable. Recommend contacting the sellers for any relevant receipts or warranty information.

Previous repairs noted exterior rear of home

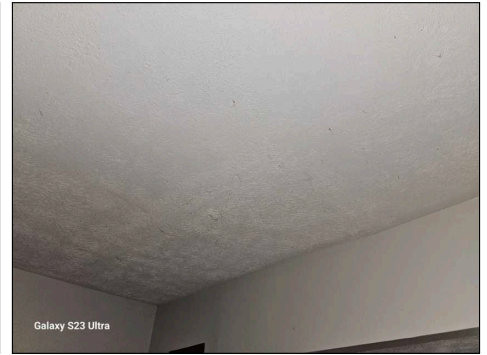
2.2. There is evidence of a previous repair at the kitchen. Repair appears serviceable. Recommend you review the Property Disclosure Statement for further information regarding this repair.

Past repair noted kitchen

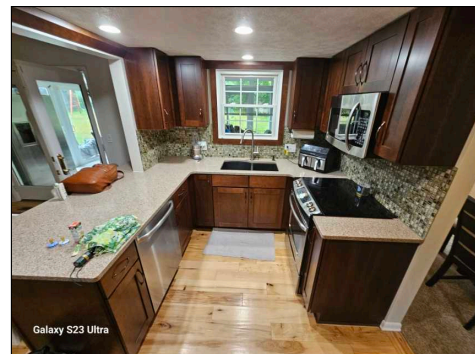
4.1. One or more cabinet doors/drawers have damaged/loose hinges at the kitchen.

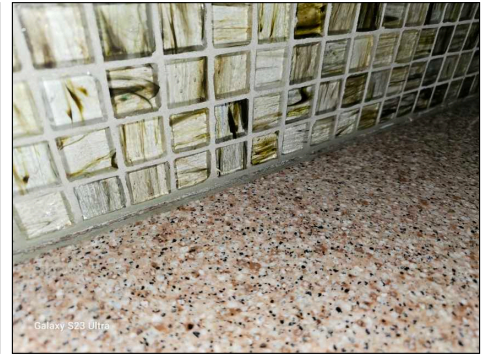
5.1. Cracked grout noted at the kitchen. Reseal/repair as needed.

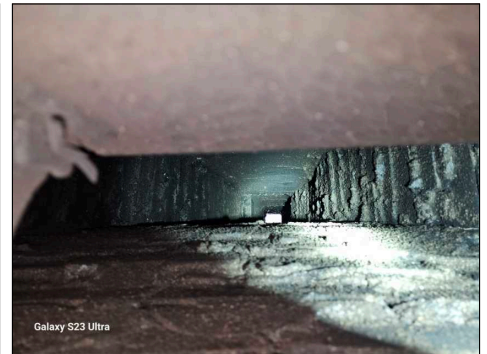
2.3. The firebox casing is loose. A repair is needed by a qualified chimney sweep.

Loose firebox casing noted

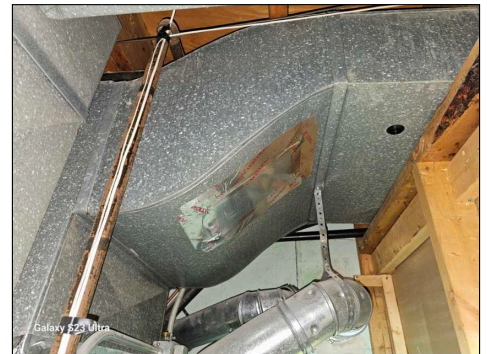
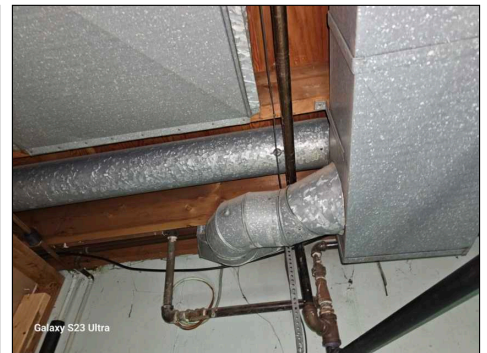
2.3. Rusted ductwork noted in the basement. Repair as needed.

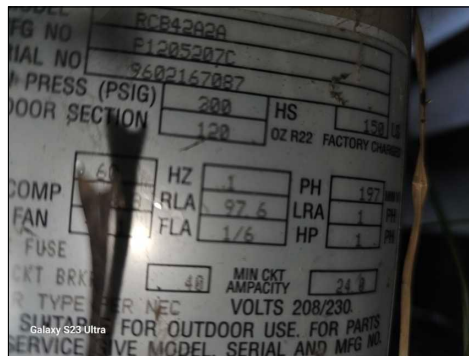
1.2. The exterior condensing unit is approximately 28 years old. The average working life is 15-20 years.

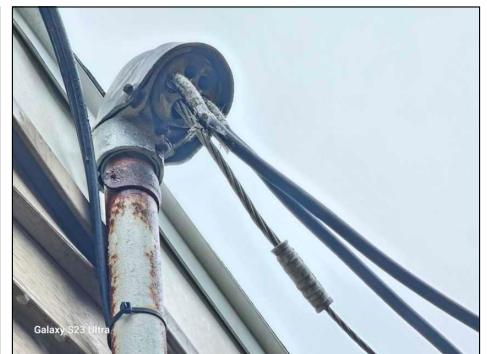
Improper drip loop noted, exterior left side

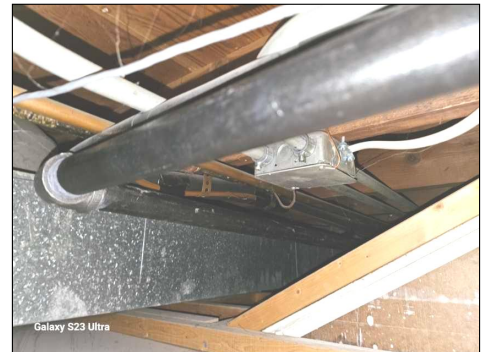
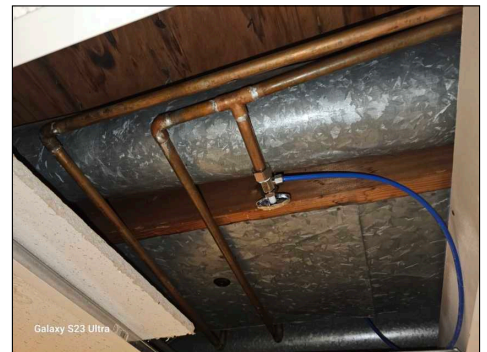
Past leaks noted

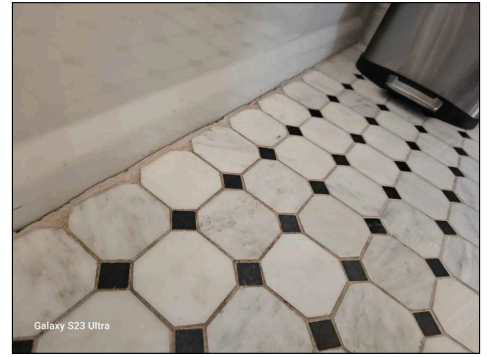
Loose to the wall master bath

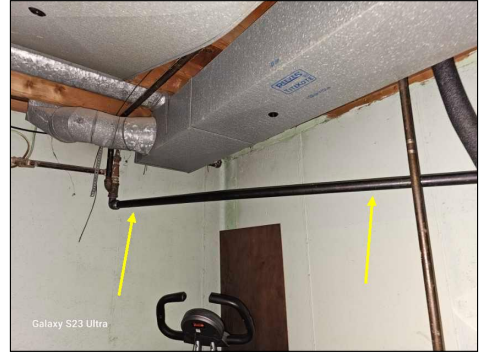
Page 55 Item: 7	Gas/LP Condition	7.2. The gas line at the basement is improperly secured. This is considered improper and is a potential safety issue until corrected. Recommend adding additional support such as a proper plumbing straps.
-----------------	------------------	---

Improperly secured gas line noted in the mechanical closet. Recommend installing proper plumbing straps.

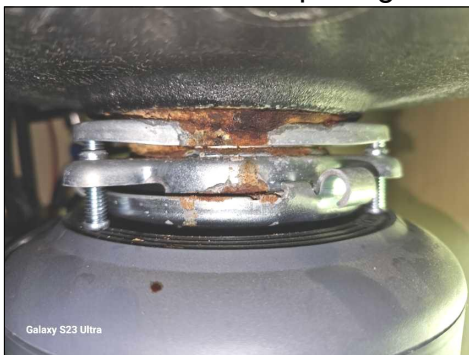
2.1. Unit is corroded and shows signs of past leaks. Recommend monitoring and repairing as necessary.

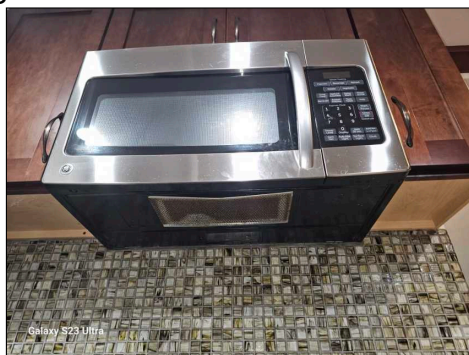
3.1. The light did not function. Check bulb first.

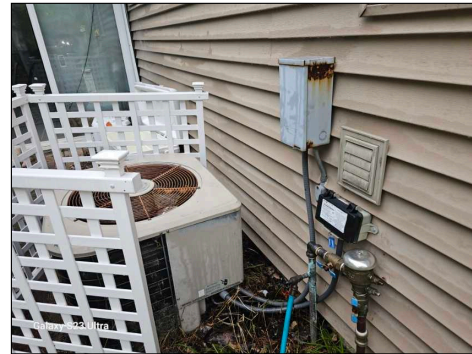
5.2. The dryer vent terminates within close proximity to the exterior condensing unit. Recommend relocated the termination of the dryer vent as necessary.
