# ***Locker Inspection Services LLC***

## **Property Inspection Report**

**1234 Locker Ln, East Grand Rapids, MI 49506**

**Date of Inspection: 6/26/2023 Time: 9:00 AM**

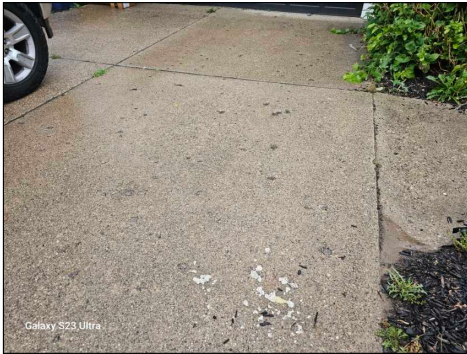
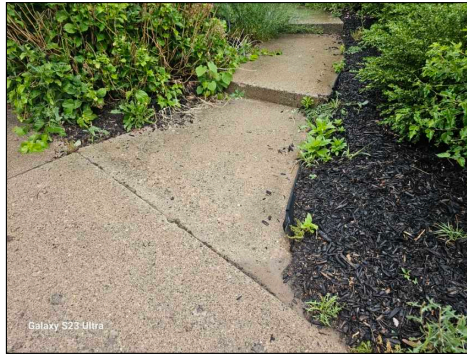
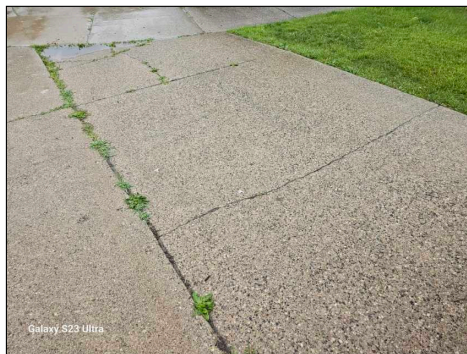
1.1. The driveway has common cracks and will need regular maintenance such as patching and sealing cracks.

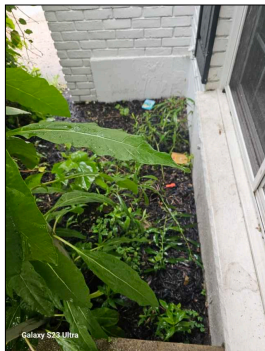
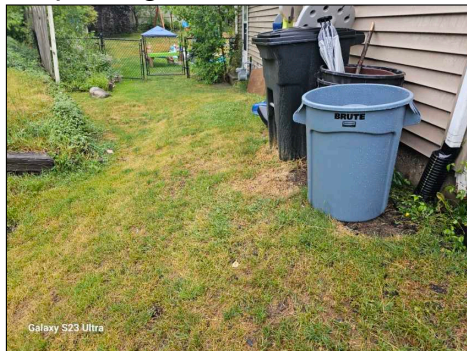
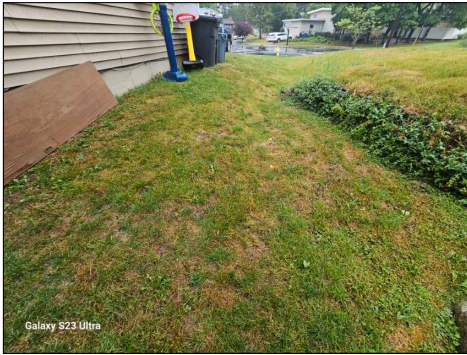
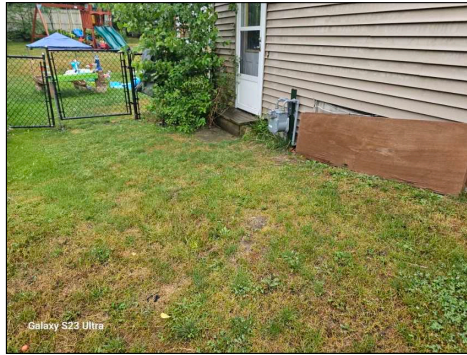
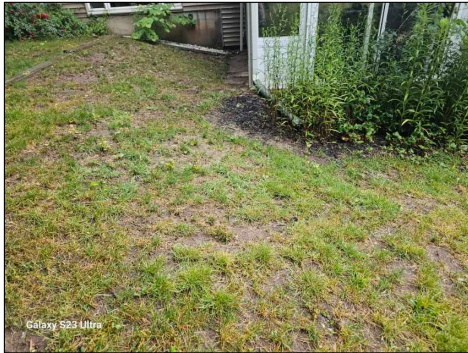
2.1. There is a negative slope at multiple areas around the home. This may allow water to pool against the foundation. Recommend regrading the area.

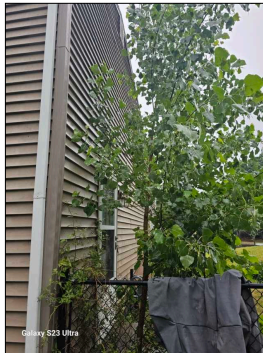
3.1. Overhanging tree branches noted over the roof. Monitor and trim as necessary.

3.2. Tree branches noted rubbing on the siding. Trim as needed to help prevent siding damage.

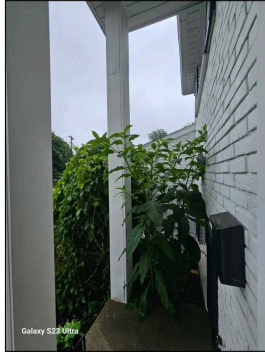
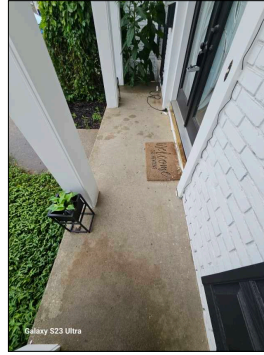
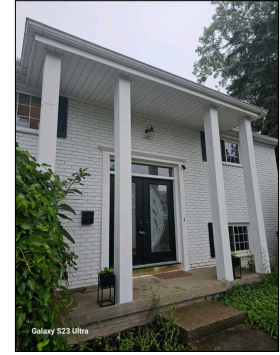
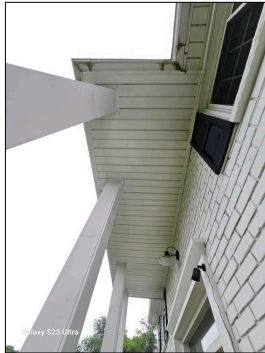
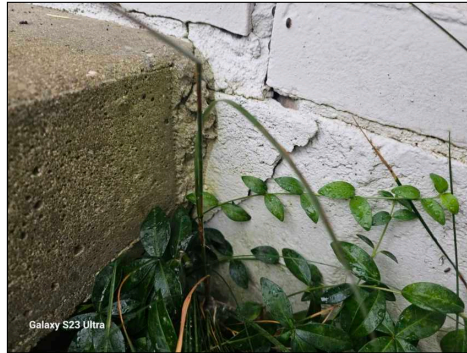
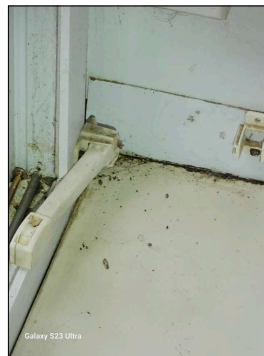
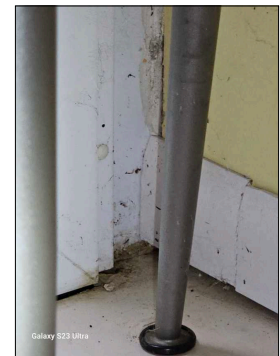
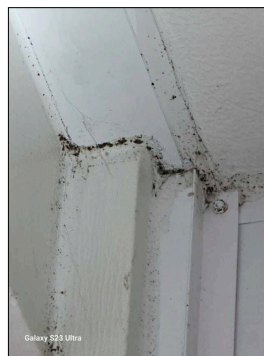
4.1. Posts are loose at the base on the porch at the front of the home. A repair is recommended.

4.2. The porch has common cracks and will need regular maintenance such as patching and sealing cracks.

4.3. Signs of past moisture intrusion noted at the back porch/sun room. No active leaks were noted at the time of inspection, recommend monitoring and repairing as needed.

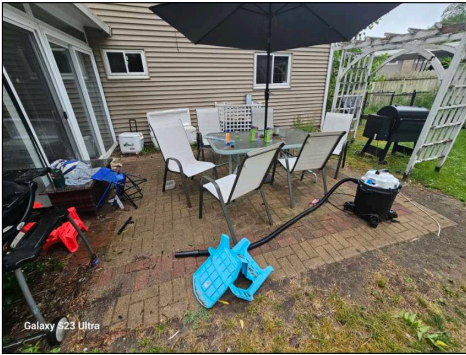
5.1. The patio at the back of the home has common cracks present.

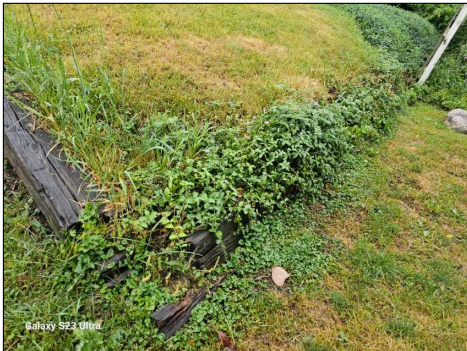
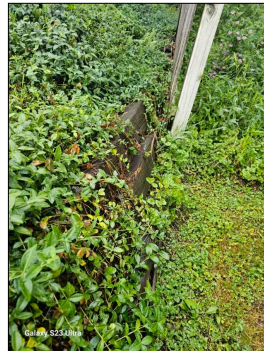
6.1. The retaining wall at the left side of the home is damaged. Repairs are needed.

6.2. The retaining wall (s) at the left side of the home are past vertical but solid. Monitor and repair as necessary.

6.3. The retaining wall at the back of the home is failing as evidenced by cracks and/or structural displacement.

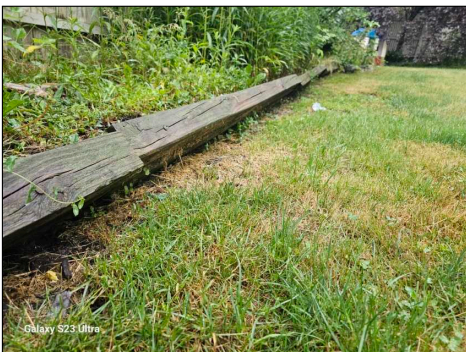
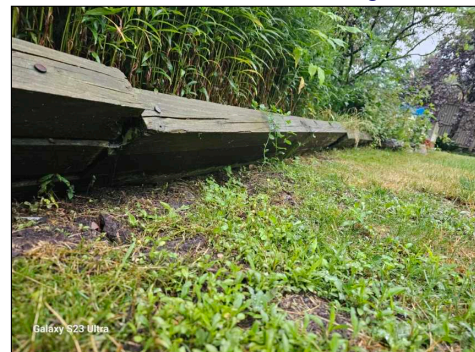
Wall failing ext rear

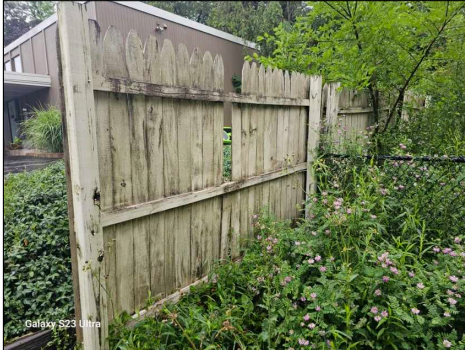
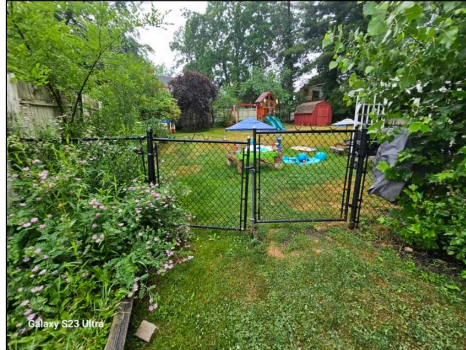
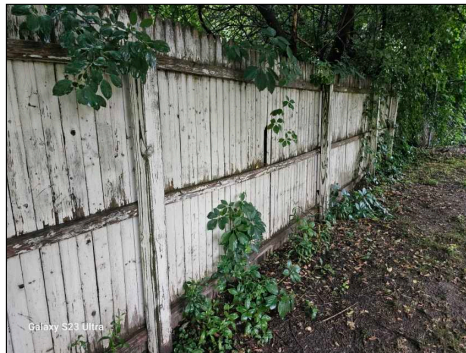
7.1. The fence/fence posts at multiple areas around the home are damaged/deteriorated.

7.2. One section of fence was loose/leaning at the back of the home. Recommend repair/replace as needed.

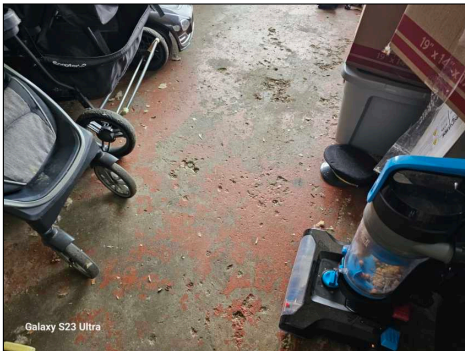
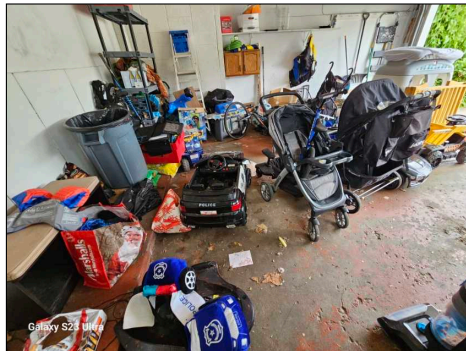
8.1. The garage floor has common cracking present. Seal and preserve as necessary.

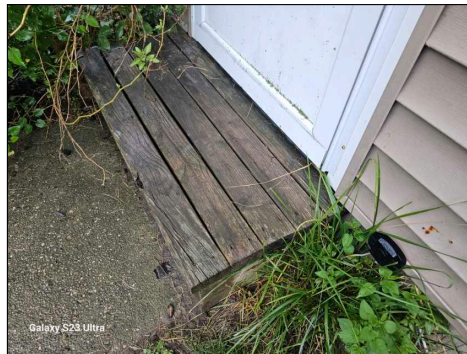
10.1. The stairs at the left side of the home have loose treads. These could pose a safety hazard and should be replaced.

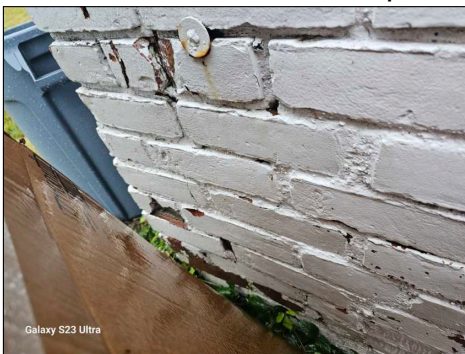
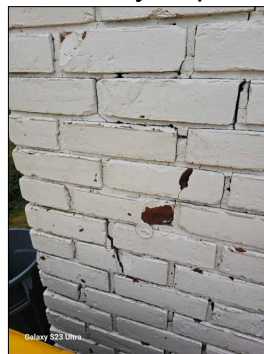
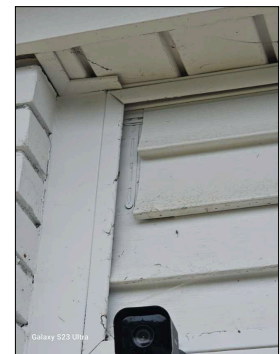
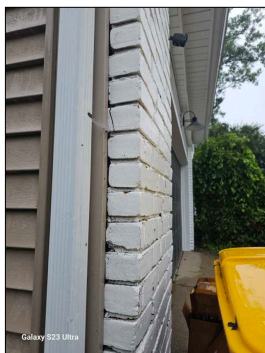
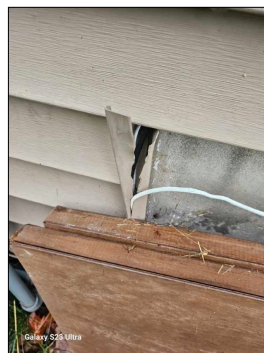
1.1. Chips, nicks, cracks and/or other cosmetic damage noted to the house and/or garage. This is typical wear and not usually a cause for concern. Repair/replace damaged sections as needed.

1.2. Siding damage noted at the right side of the home. Repairs are needed to seal and correct potential water entry points.

1.3. Gaps/openings in the siding noted at the front of the home. Repair and maintain sealant as needed.

1.4. Cracks noted in the brick siding at the front of the home. Repairs are recommended by a qualified masonry contractor.

1.5. Spalling brick noted at the front of the home. Seal and maintain as necessary.

1.6. The brick siding at the exterior front side is pulling away from the home. A repair is recommended by a qualified masonry professional.

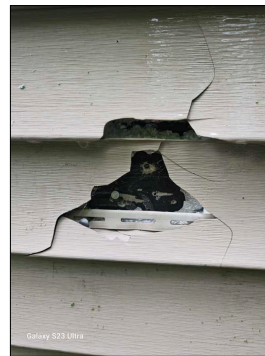
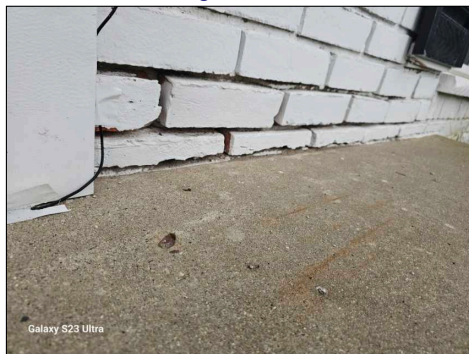
Unconventional repair noted exterior right side.

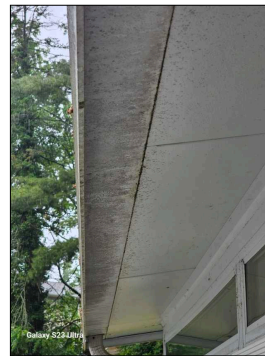
2.1. Damage noted to the fascia and/or soffit near the chimney. Recommend monitoring and repairing as necessary.

2.2. Moisture staining noted on the soffit/fascia at the back of the home. This may indicate the presence of moisture behind finished surfaces. Recommend further evaluation/correction by a qualified contractor.

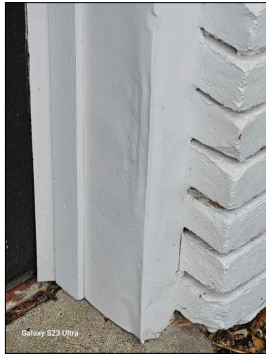
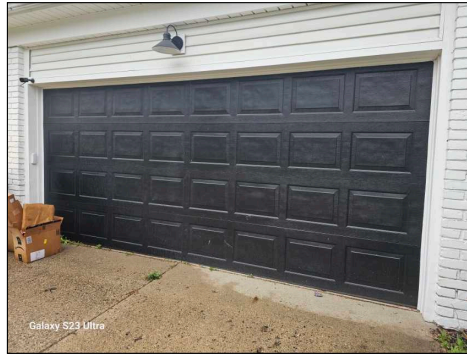
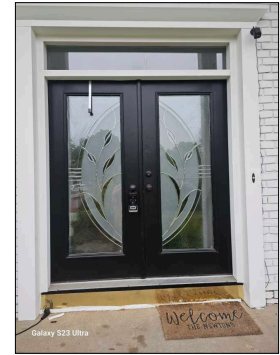
3.1. Moisture damaged frame noted at the base of the entrance door at multiple areas around the home, repairs recommended to the frame, threshold and any other damaged underlayments.

3.2. The exterior storm/screen doors at the back of the home has a damaged screen.

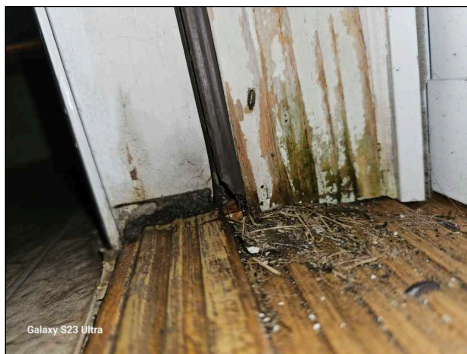
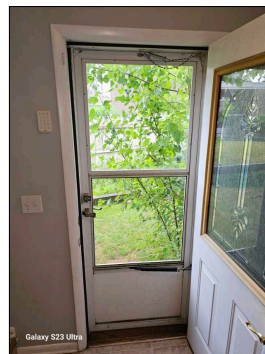
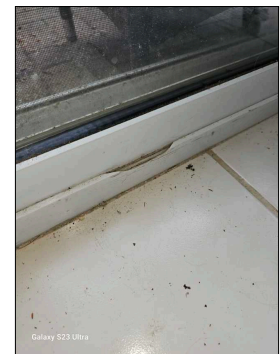
Damage noted back sun room sliding glass door casing

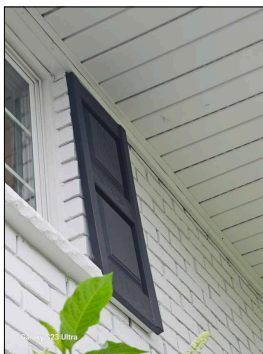
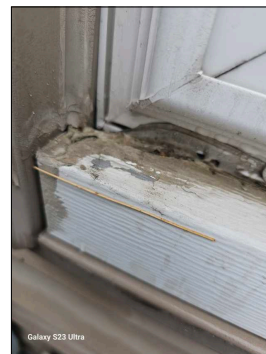
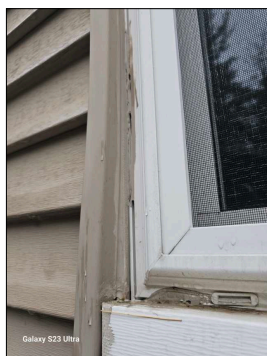
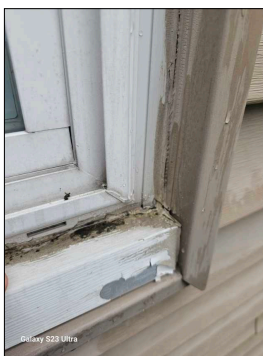
4.1. Cracked / deteriorated caulking noted at one or more exterior windows.  
Repair / maintain as required.

4.2. Loose shutters noted at one or more exterior areas—repair/properly  
secure as needed.

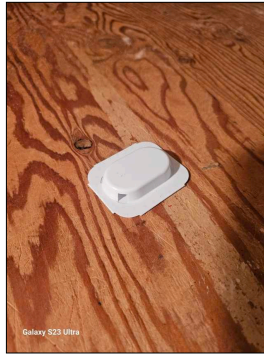
5.1. Ant traps noted. No live activity was noted at the time of inspection.

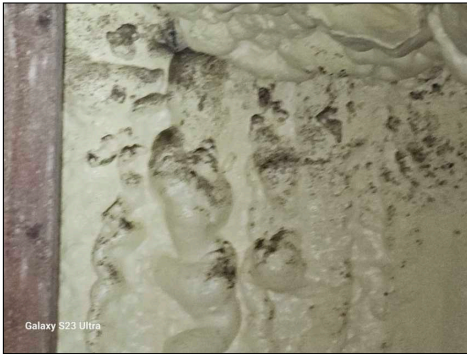
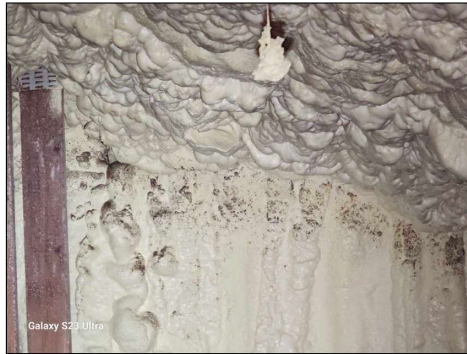
6.1. Potential microbial growth noted at one location. No testing was done to determine if this is a health hazard. We suggest further testing by Locker Inspection Services and cleaning with distilled white vinegar.

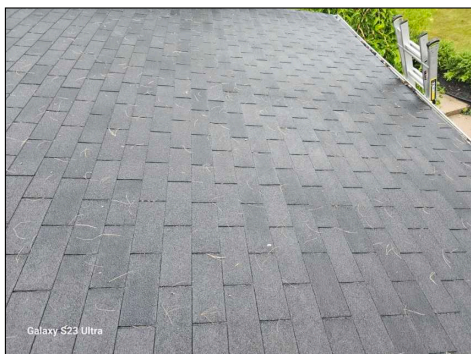
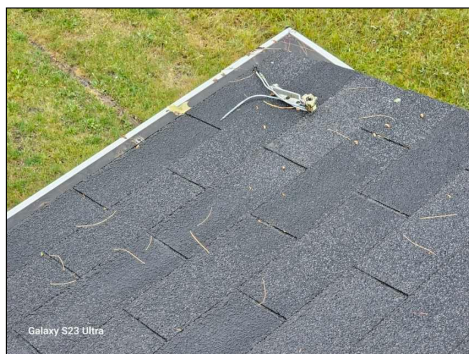
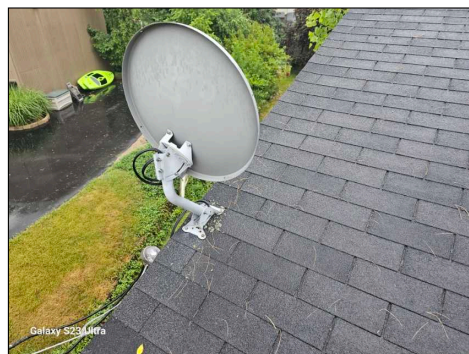
2.3. Average granule loss noted at a few areas on the roof. This is considered normal ware and tare. Recommend monitoring/repairing if condition worsens.

2.4. Shingle tabs are torn off and missing at the exterior rear. Repairs are needed by a qualified roofer.

2.5. There are areas with previous repairs noted at the the back . Repairs appear to be serviceable. Recommend monitoring and repairing as necessary.

2.6. The rubber membrane roof has low areas that hold water. No signs of leaks were observed, but we recommend further review by a qualified roofer.

2.7. The roof covering material is still functional but is showing signs of aging and weathering. Yearly maintenance and any necessary repairs are recommended for its remaining life.

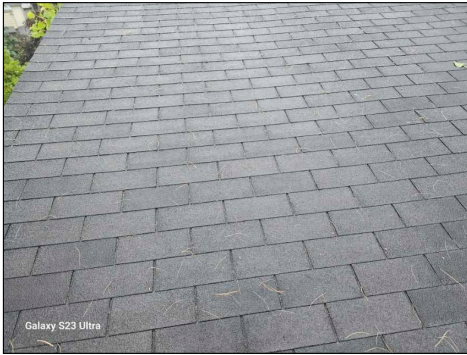
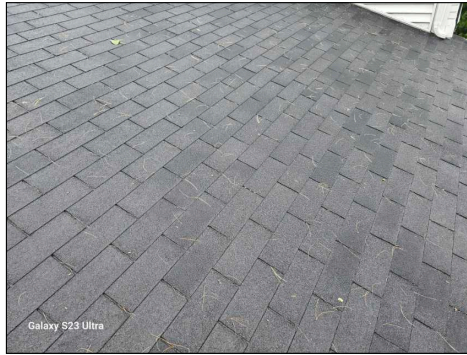
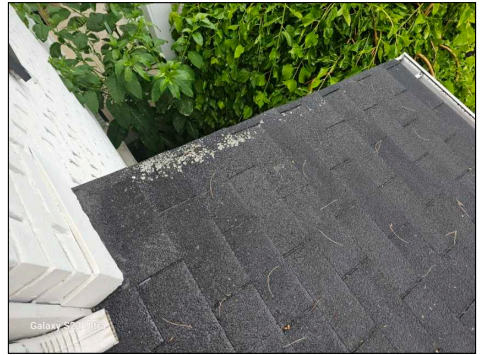
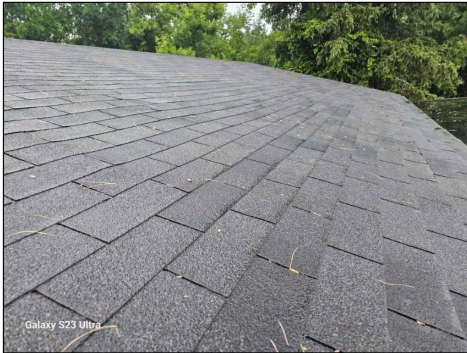
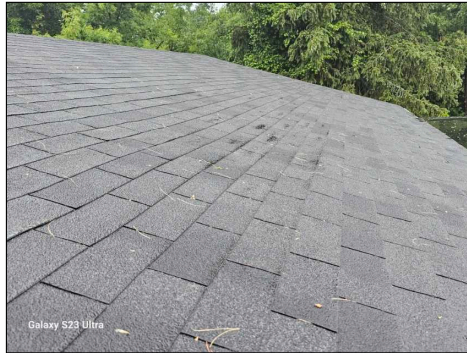
Deviation noted front side

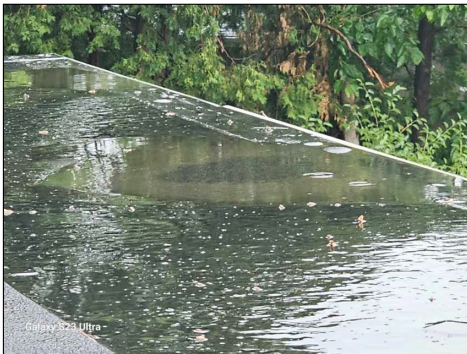
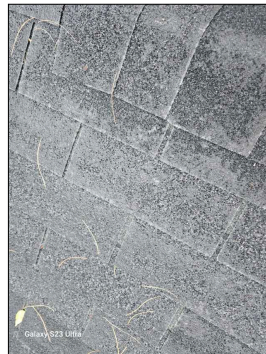
Low spots noted front side porch

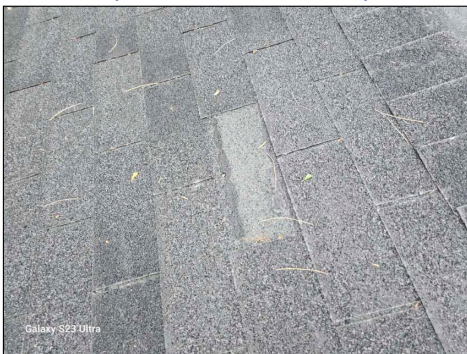
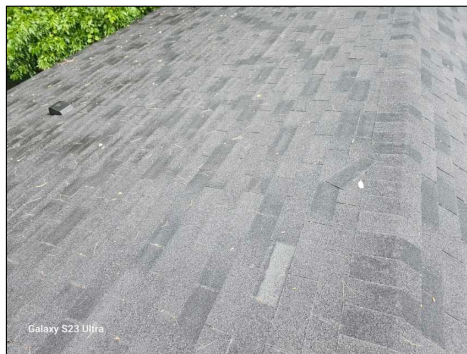
Missing tab noted rear

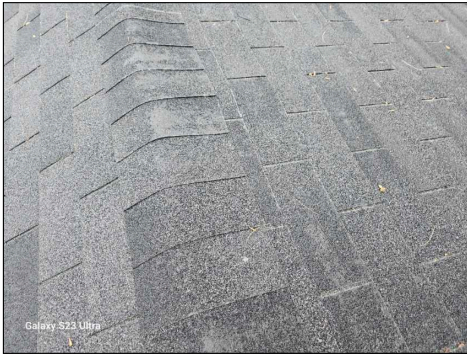
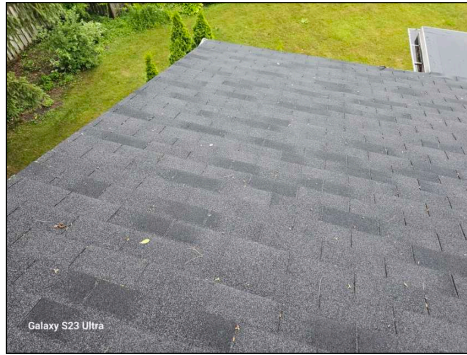
Previous repairs noted at the rear

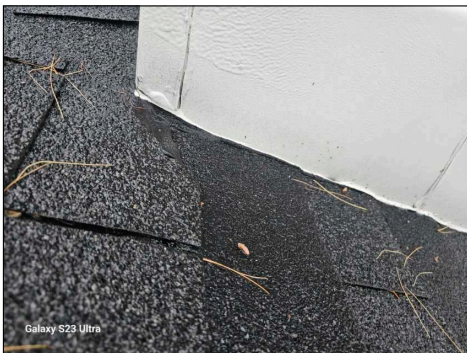
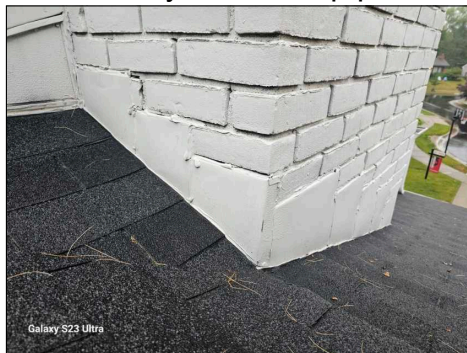
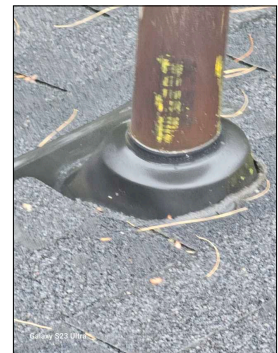
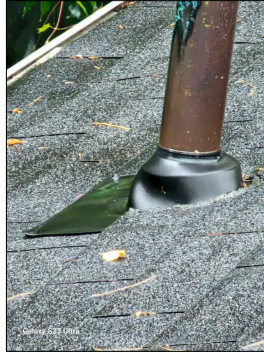
3.1. Mastic (tar) covered flashing is present at roof penetration areas. This product was applied as a repair or maintenance to the areas. The use of this product is acceptable, but it will require regular review and maintenance to ensure its serviceability and to help prevent water penetration.

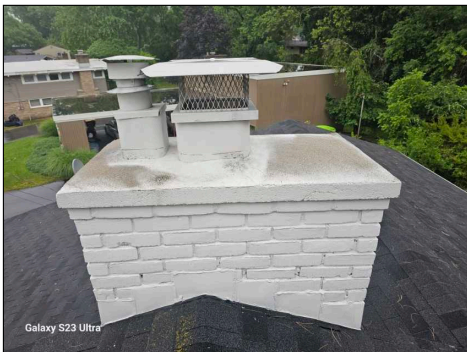
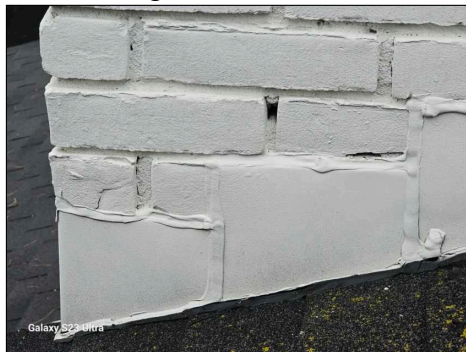
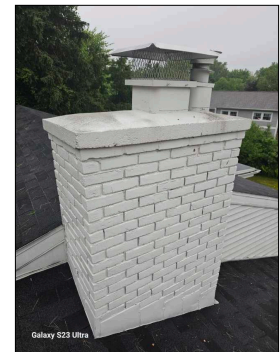
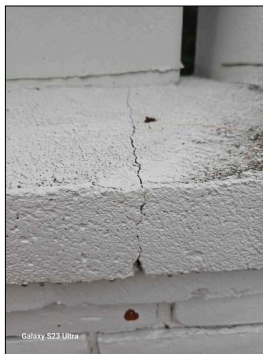
4.4. The crown is cracked and needs maintenance repairs to help keep moisture from causing deterioration.

Cracked crown noted

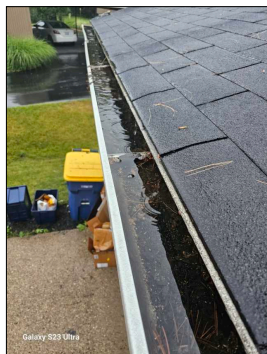
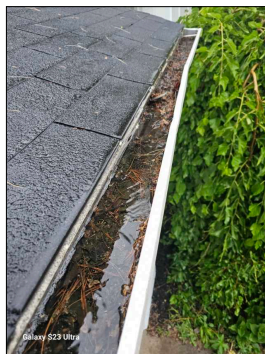
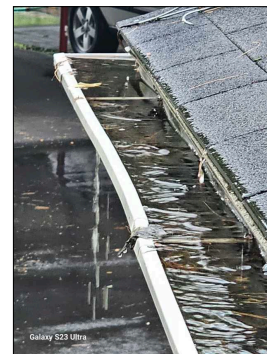
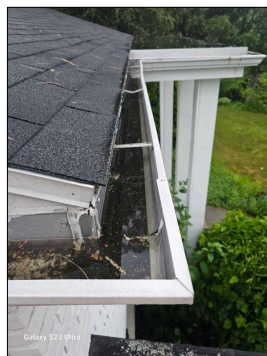
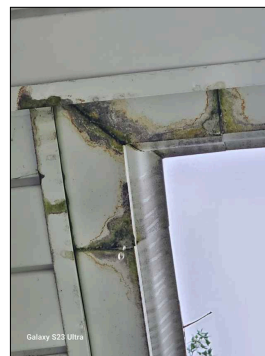
5.1. The gutters are leaking at multiple connection points. General maintenance and repairs are recommended.

5.2. The gutters at multiple areas have debris present and should be cleared of debris to determine if they drain properly.

5.3. The gutter is poorly sloped and will not drain properly at multiple areas around the home.

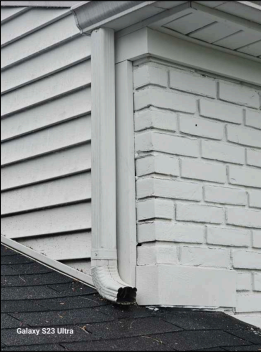
6.1. The downspouts terminate next to the house and should have extensions added to divert water at least 6' from the foundation.

Extensions needed exterior upper level front side.

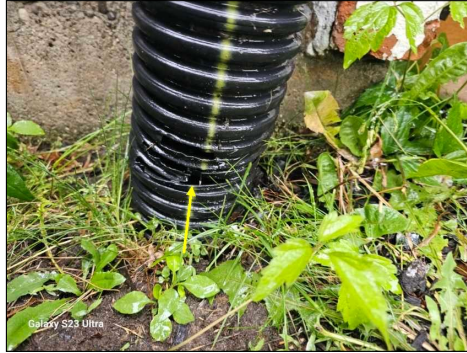
Damaged downspout extension noted front side. This should be properly sealed/repaired.

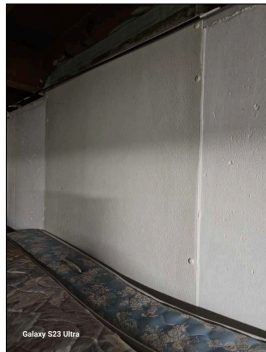
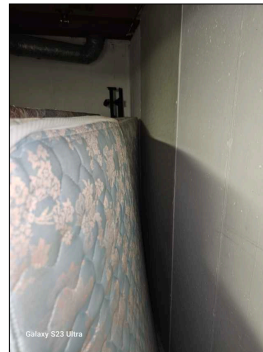
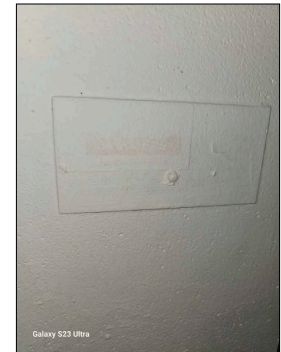
2.2. Previous repairs observed on the foundation walls. Repairs appear serviceable. Obtain any warranties or receipts that may apply and monitor for additional cracking.

Previous repair noted storage room

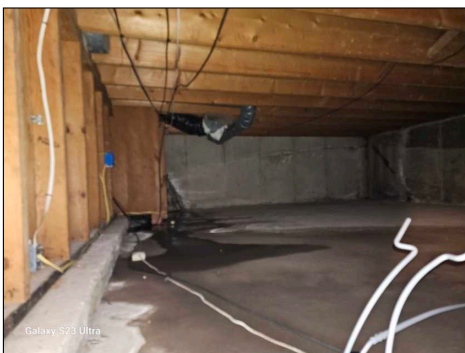
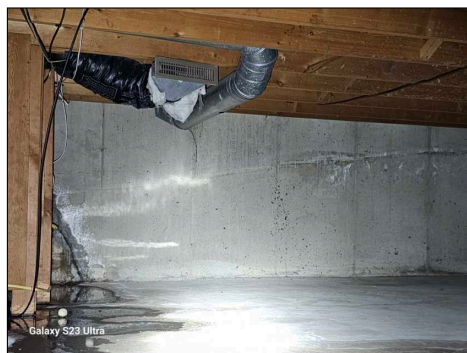
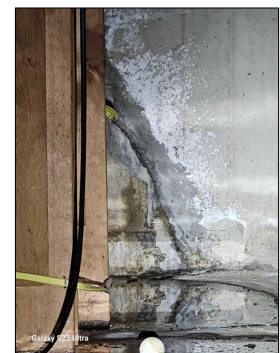
3.2. Previous repairs are failing on the foundation walls at the front foundation wall. Further evaluation and repairs are recommended by a qualified professional.

Previous sealant repairs failing at the crawlspace. This should be resealed/repared by a qualified foundation specialist.

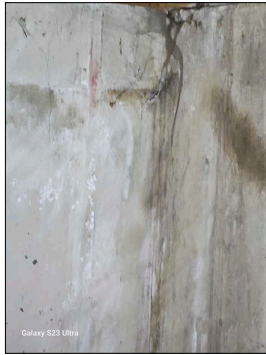
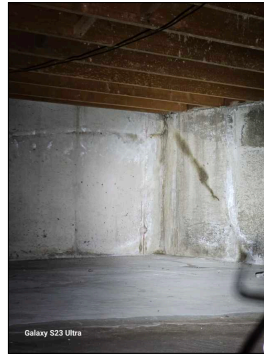
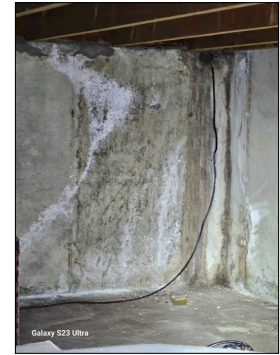
Moisture intrusion noted at the crawlspace

8.2. Water entry observed in the crawlspace at the left side foundation wall. Recommend all entry points be sealed, ensure all grading slopes away from the property, and all gutters and downspouts properly divert water away from the foundation.

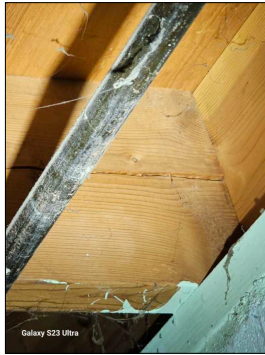
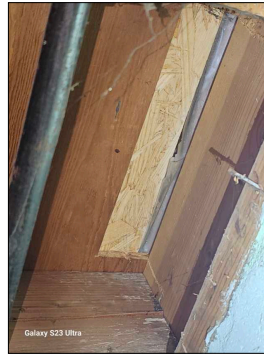
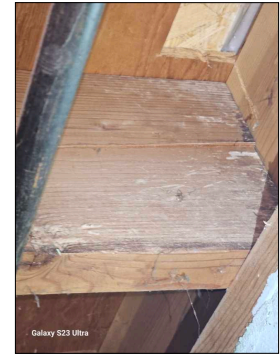
5.4. Previous repairs observed on the framing. Repairs appear serviceable. Obtain any warranties or receipts that may apply and monitor for additional cracking.

Sealed register/previous repairs noted  
at the sub-flooring

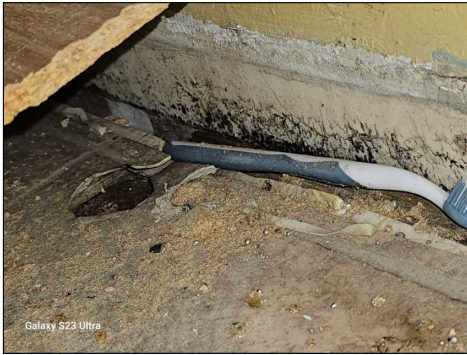
7.1. Potential microbial growth noted at one or more locations. Testing is currently being performed to determine if this is a health hazard.

Microbial growth noted, laundry room,  
under utility sink

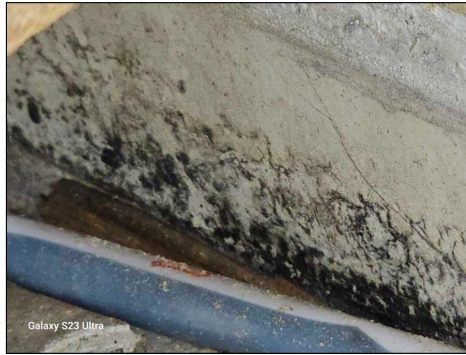
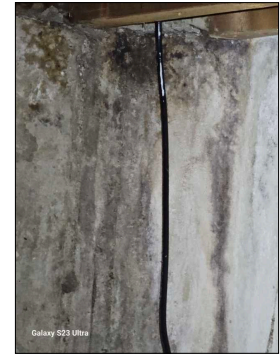
Potential mold growth noted at the  
crawlspace

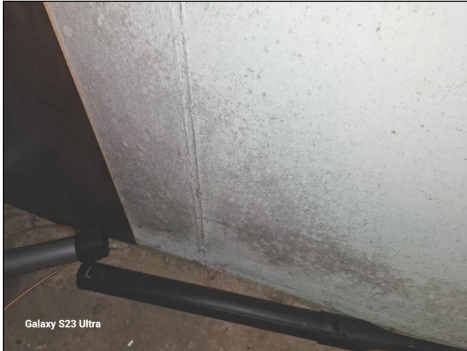
Potential mold growth noted storage  
room

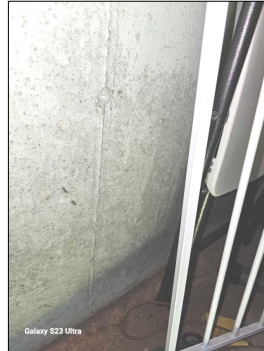
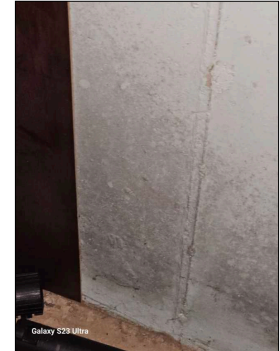
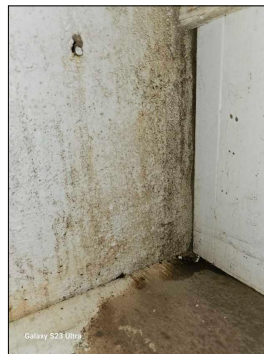
Potential mold growth noted crawlspace

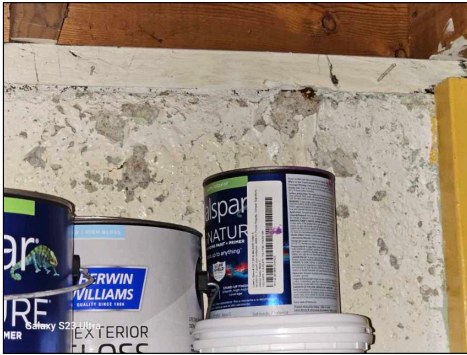
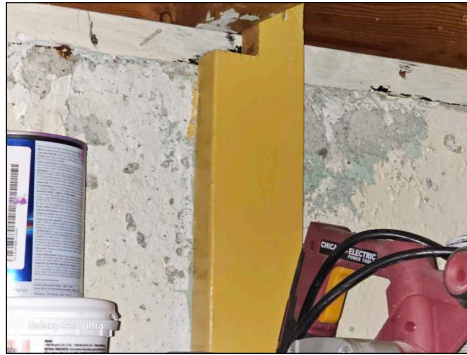
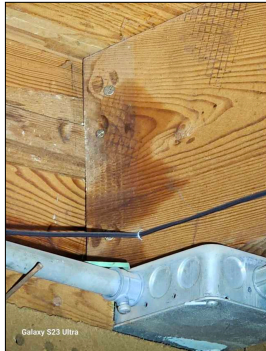
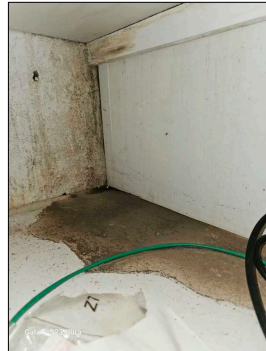
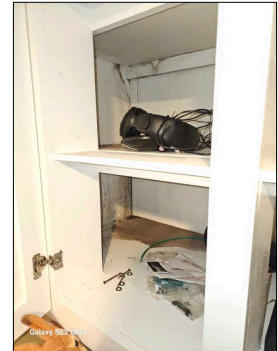
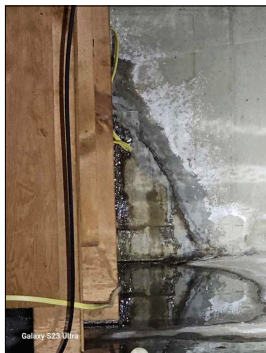
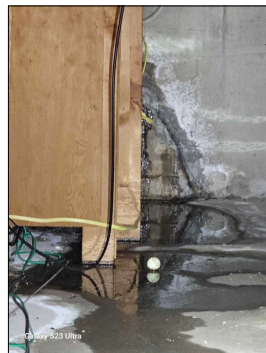
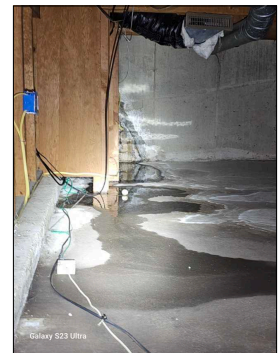
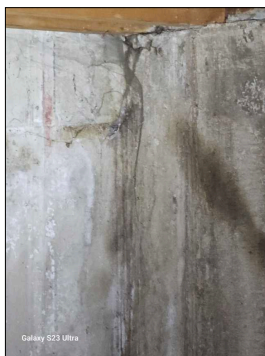
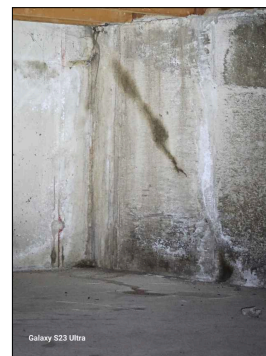
8.1. Efflorescence is a crystalline deposit of salts that can form when water is present in or on concrete. This is noted at the basement foundation walls, although this is usually a harmless phenomenon, this does indicate moisture intrusion. We cannot determine if the moisture entry has stopped or if it is ongoing. Refer to the seller's disclosure and have the cracks professionally evaluated and sealed as necessary.

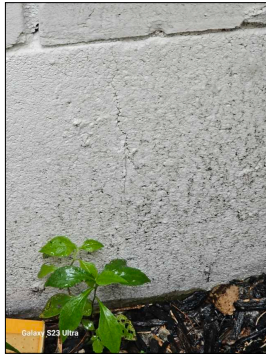
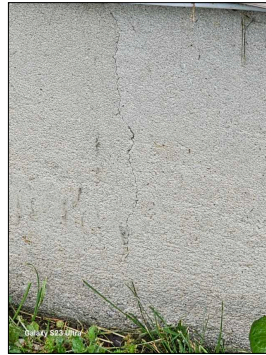
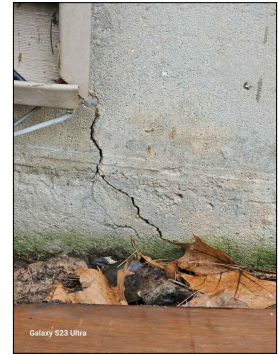
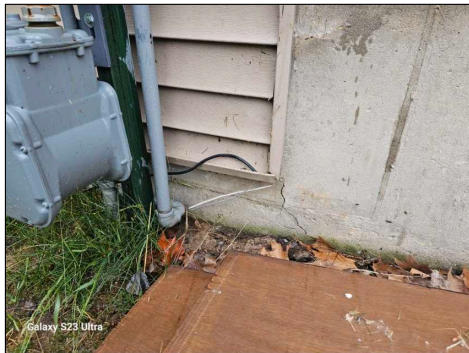
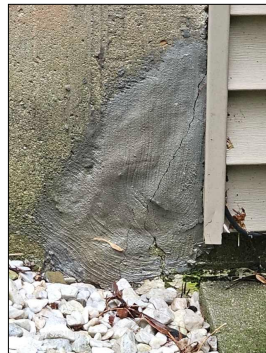
9.1. The stem wall(s) at multiple areas around the home have common cracks present. While these may not be structurally significant, they may allow water penetration. Monitor and repair as necessary.

9.2. Past repairs noted on the foundation at the back of the home. Repairs appear to be serviceable. Recommend contacting the sellers for any relevant receipts or warranty information.

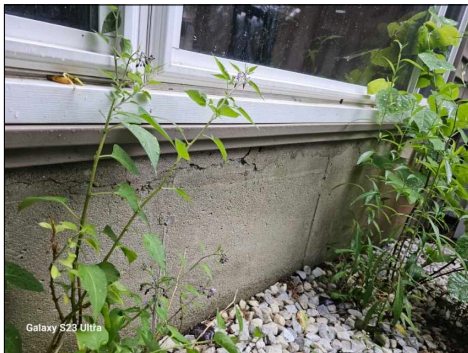
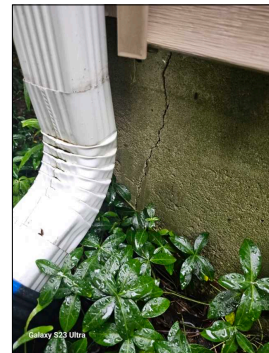
Previous repairs noted exterior rear of home

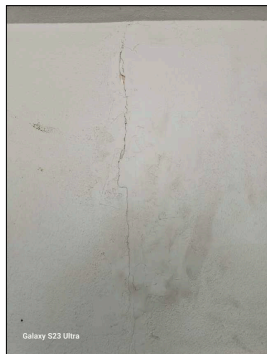
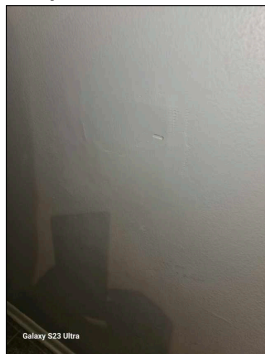
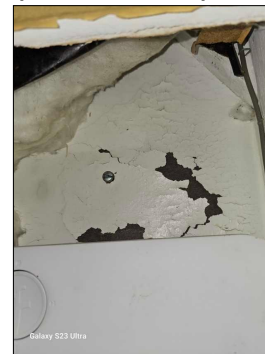
1.1. Cracking/damage noted on the wall at multiple areas of the home. Recommend monitoring for additional movement and patching and repairing as needed.

1.2. Indications of previous water issues observed as evidenced by dry water stains at the kitchen. The area tested negative with a moisture meter at the time of the inspection, however, we cannot confirm the source of the moisture has been repaired. Have the seller provide proof of adequate repair.

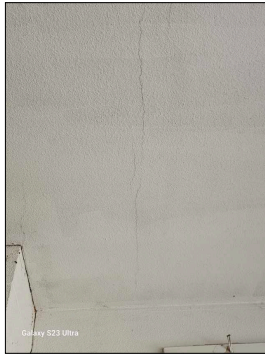
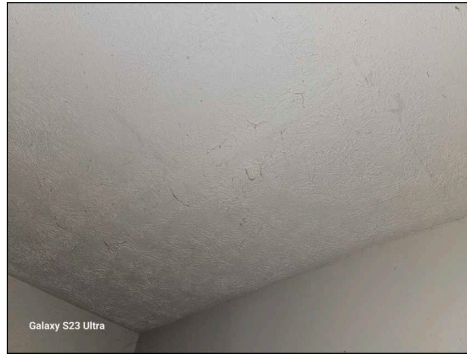
2.1. Cracking noted on the ceiling at multiple areas of the home. In our opinion this is normal settling. Recommend repair and monitor for additional movement.

2.2. There is evidence of a previous repair at the kitchen. Repair appears serviceable. Recommend you review the Property Disclosure Statement for further information regarding this repair.

Past repair noted kitchen

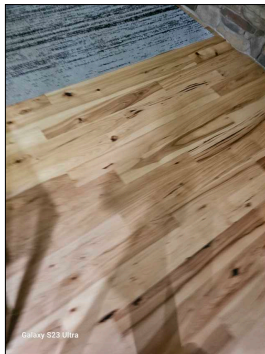
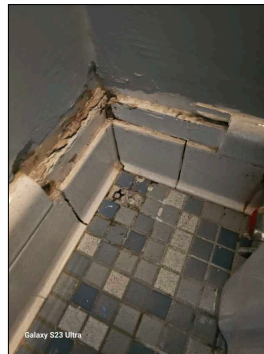
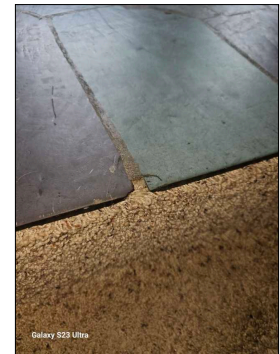
3.1. Damaged flooring material noted at multiple interior areas. Repair as needed.

Master bathroom damaged tile noted.

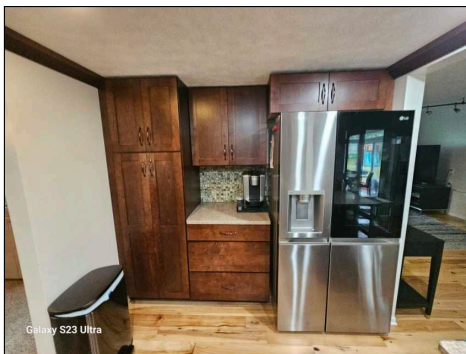
4.1. One or more cabinet doors/drawers have damaged/loose hinges at the kitchen.

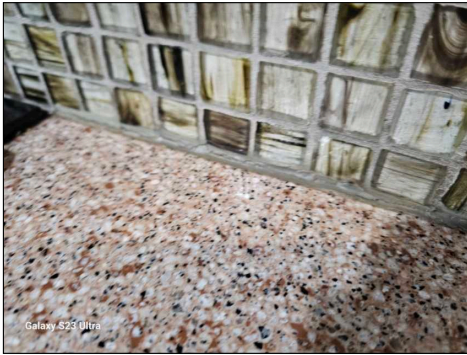
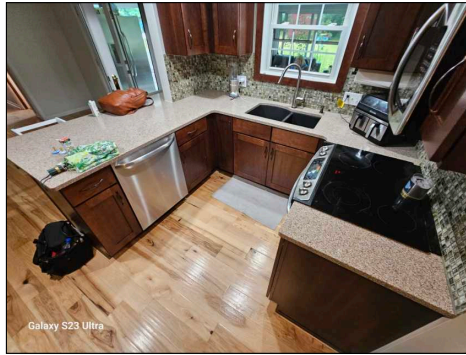
5.1. Cracked grout noted at the kitchen. Reseal/repair as needed.

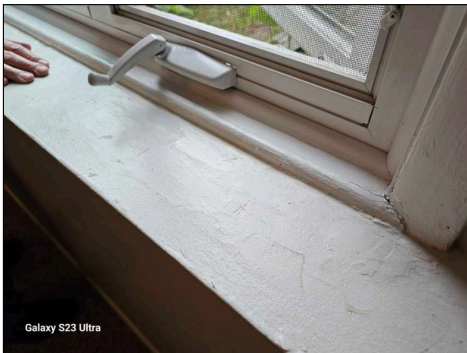
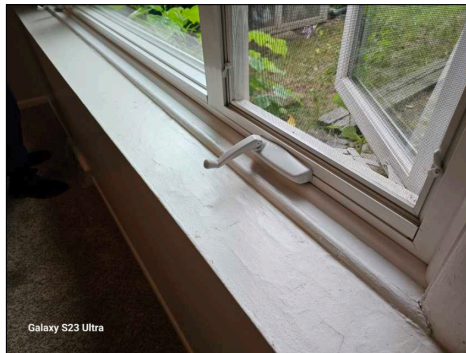
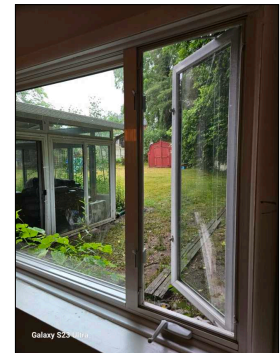
6.1. Indications of previous water issues observed, as evidenced by dry water stains at various interior windows. The area tested negative with a moisture meter at the time of the inspection. Have seller provide proof of adequate repairs.

6.2. One or more window cranks are damaged / non functional at the upper level. Replacement hardware is needed for proper operation.

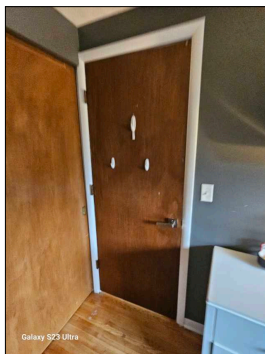
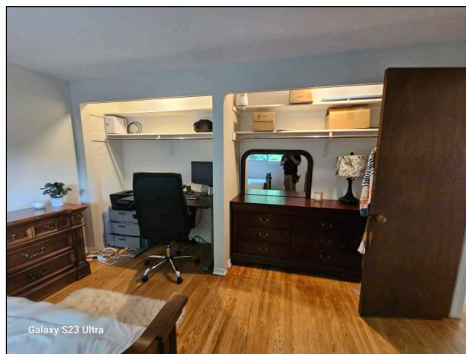
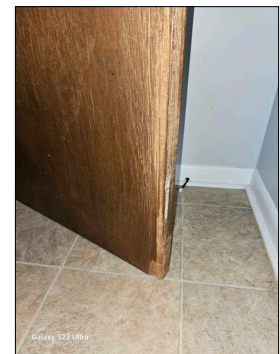
7.1. One or more doors rubs on the jamb when opening / closing at multiple areas of the home. This is generally no cause for concern and indicates normal settling. Repair as needed.

7.2. One or more interior doors at the main floor is damaged on the door/frame.

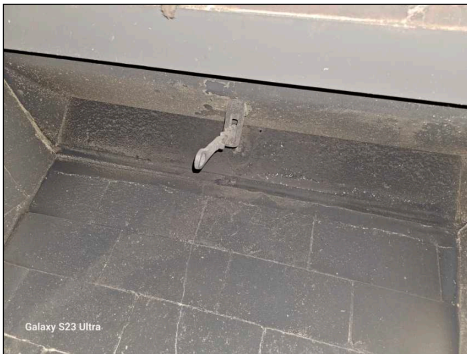
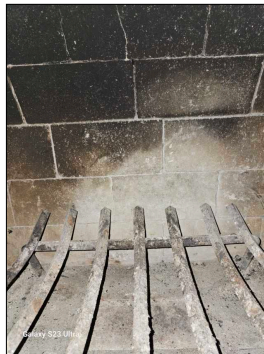
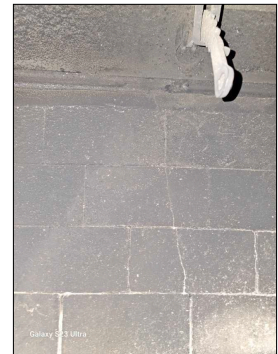
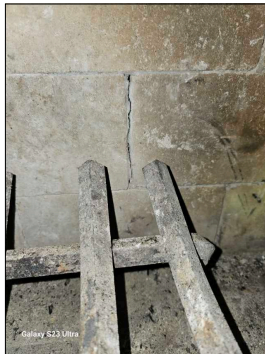
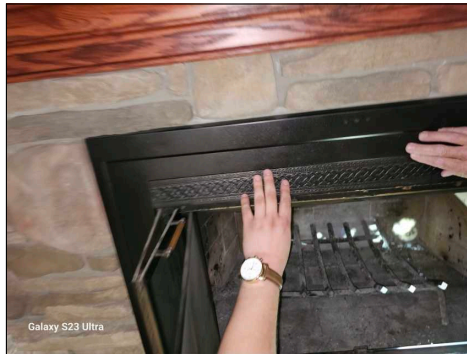
2.2. The firebox has broken bricks. Correction is needed before use.

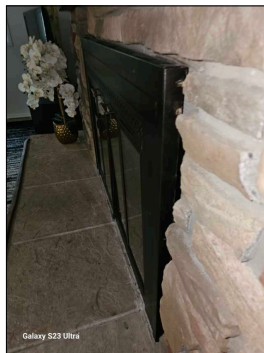
2.3. The firebox casing is loose. A repair is needed by a qualified chimney sweep.

Loose firebox casing noted

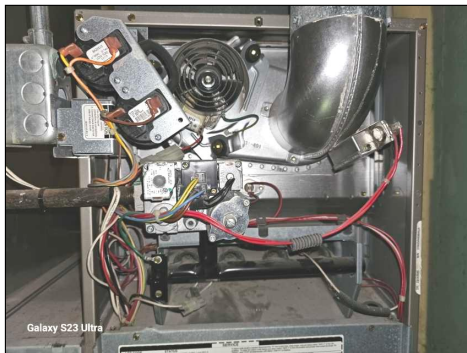
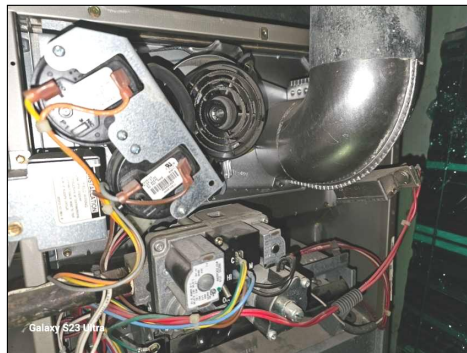
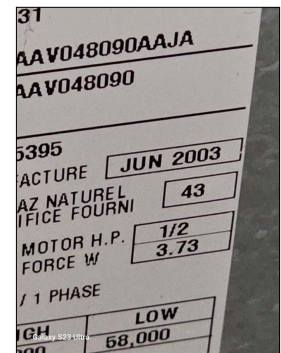
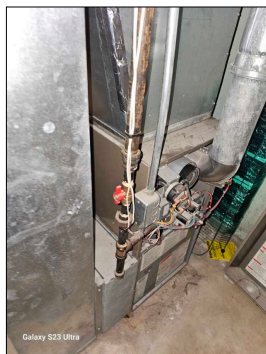
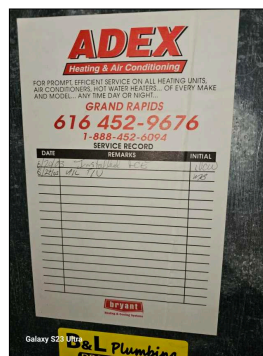
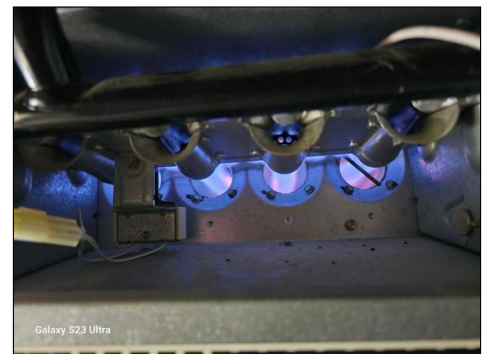
1.4. The furnace is approaching, or at, the end of its expected design life. The system will need maintenance and repairs in the future. The following are recommended:

1. Place the system under a maintenance service contract.
2. Have the heat exchanger checked at the start of each heating season.
3. Install carbon monoxide detectors at the primary sleeping areas.
4. Consider purchasing a home warranty.

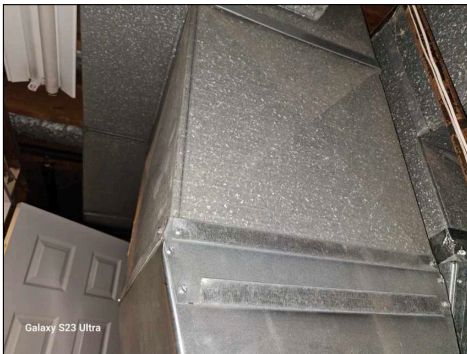
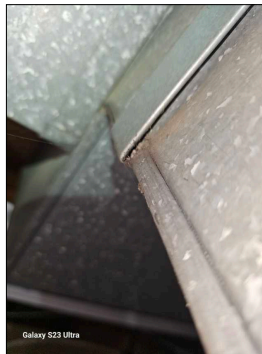
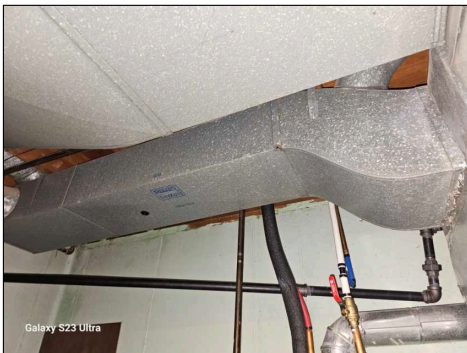
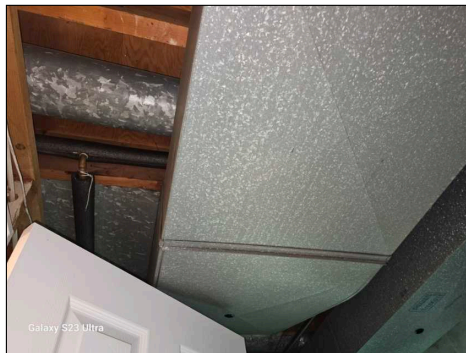
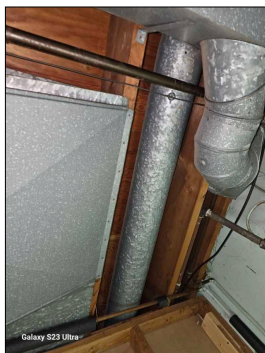
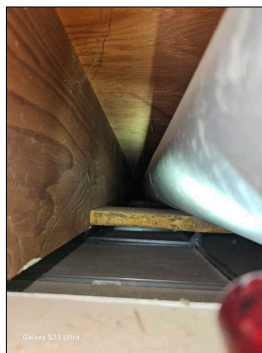
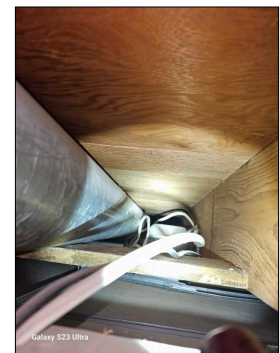
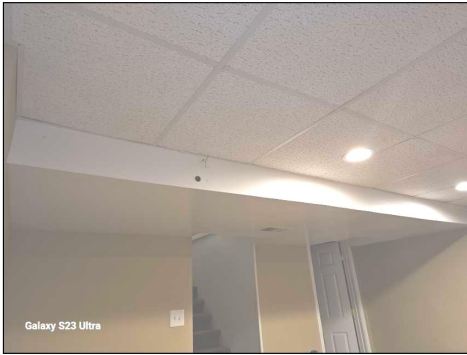
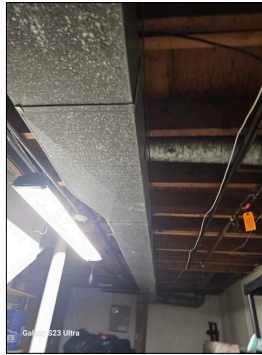
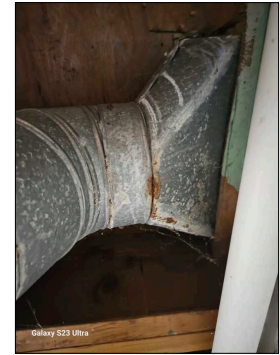
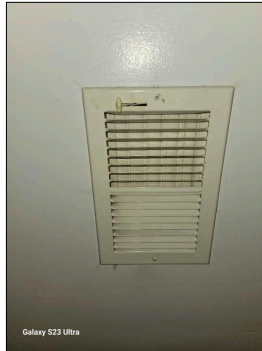
2.2. The ductwork shows signs of being dirty as evidenced by dark areas around registers. You should consider having the ductwork professionally cleaned and sealed.

2.3. Rusted ductwork noted in the basement. Repair as needed.

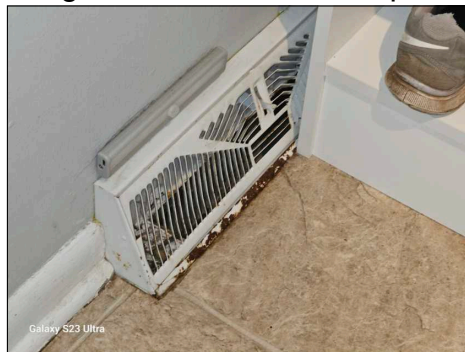
3.1. Multiple registers were rusted. Repair/replace as needed.

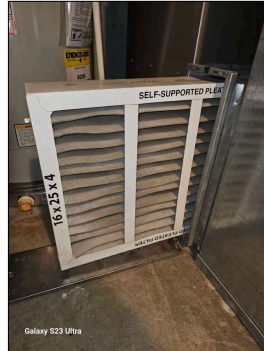
5.1. Furnace filter is dirty and replacement is needed.

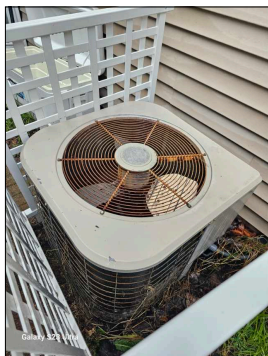
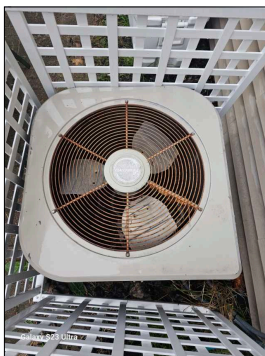
1.1. The air conditioning unit is at or past the typical life span. We cannot predict the future performance of the unit, but recommend regular service and cleaning.

1.2. The exterior condensing unit is approximately 28 years old. The average working life is 15-20 years.
