# ***Locker Inspection Services LLC***

## **Property Inspection Report**

**1234 Locker Ln, East Grand Rapids, MI 49506**

**Date of Inspection: 6/26/2023 Time: 9:00 AM**

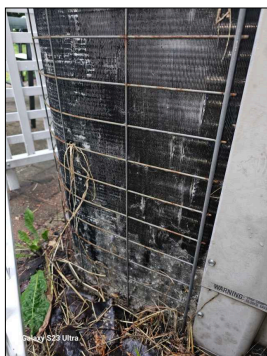
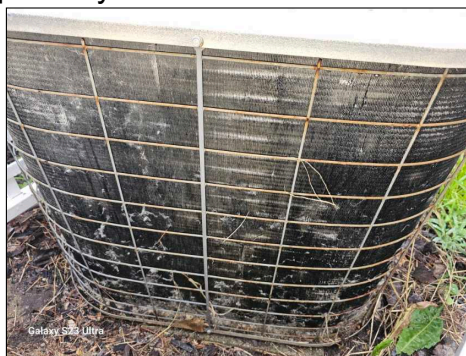
2.1. The AC system compressor is dirty and should be cleaned before regular use. This can affect system performance.

2.2. The AC System compressor fins are damaged/flattened. This can cause the unit to not operate properly and possibly reduce the life of the unit.

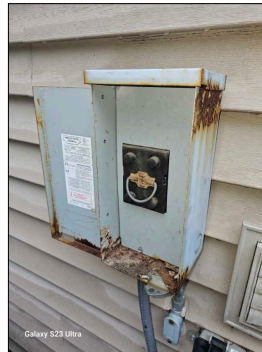
5.1. The electrical disconnect box is rusted. Recommend monitoring and repairing as needed.

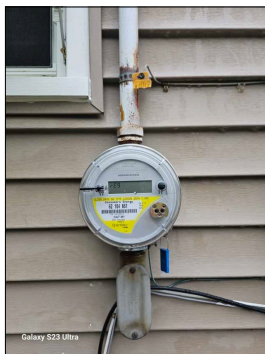
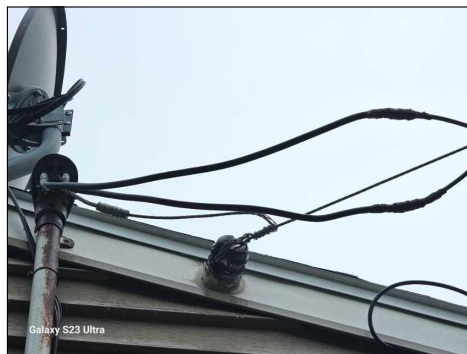
1.1. The electrical service wire at the left side of the home is showing signs of aging and wear. This is common for homes of similar age however we recommend further reviews/repairs by a qualified electrician.

1.3. The electrical mast is leaning and missing support brackets. Repairs are needed to ensure proper support.

1.4. An outdated electrical service was noted for the home. This may not meet today's current electrical standards and requirements for the home. Recommend further reviews/upgrades by a qualified electrician.

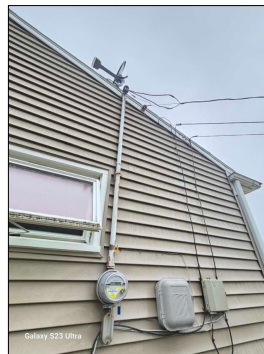
1.2. The overhead electrical service at the left side of the home has an improper drip loop present. Recommend further reviews/repairs by a qualified electrician as necessary.

Improper drip loop noted, exterior left side

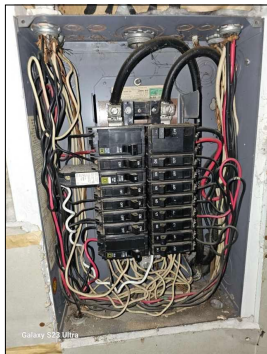
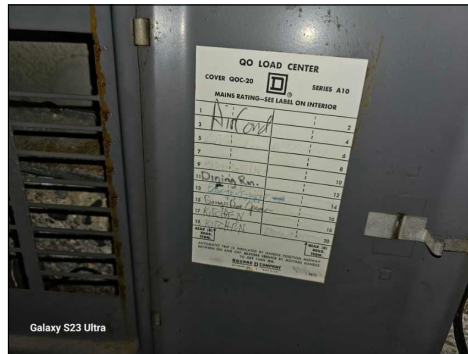
2.1. The circuits are not properly labeled and should be correctly identified by an electrician.

2.2. The main electrical shut off breaker was not located and should be demonstrated by sellers or have one installed by a qualified electrician.

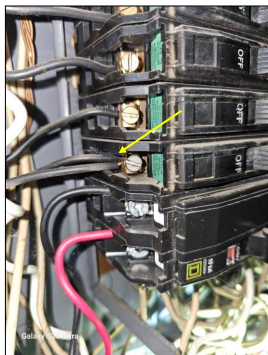
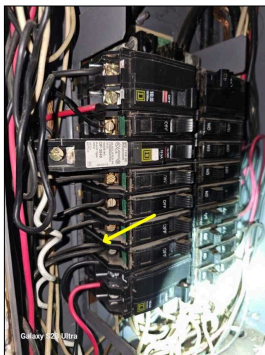
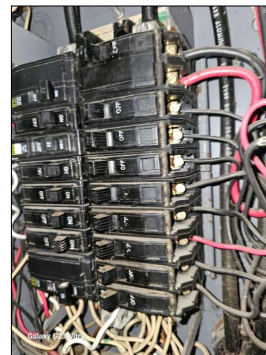
3.1. There was one double tapped breaker noted in the main panel. There should only be one wire to each breaker and should be corrected.

Double tapped breaker noted

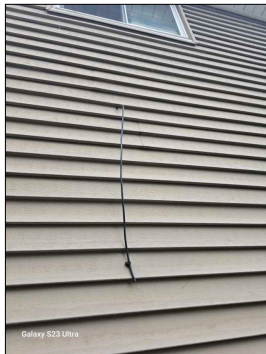
Cut data lines noted at multiple exterior areas.

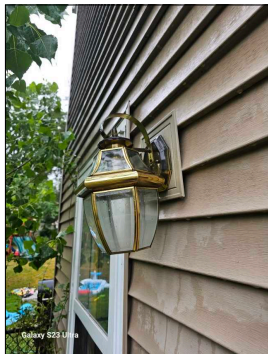
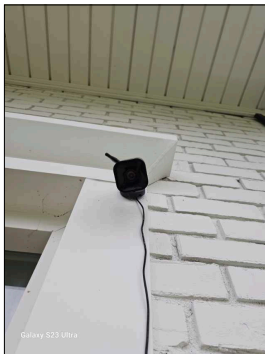
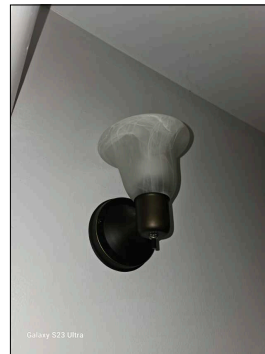
6.1. The exterior light fixture at the left side of the home is improperly secured..

6.2. The light fixture at multiple areas of the home did not operate (check bulb first).

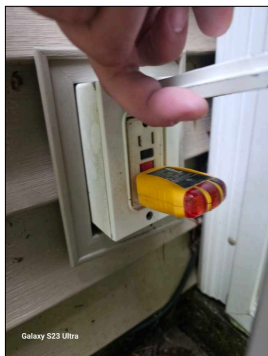
7.3. No power noted to one or more outlet(s) in the exterior rear of the home.

N.P exterior rear **GFC**

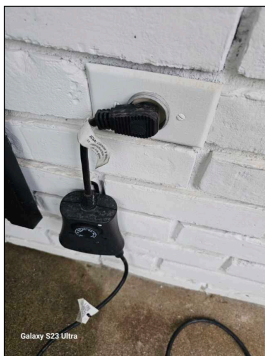
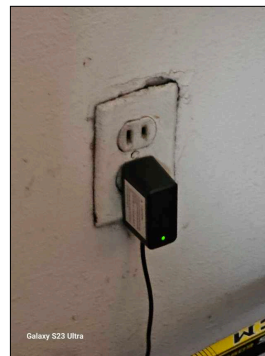
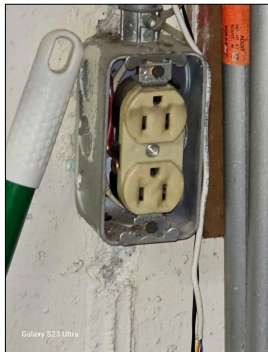
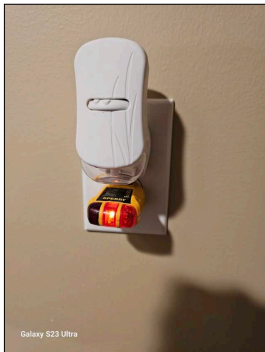
O.G basement

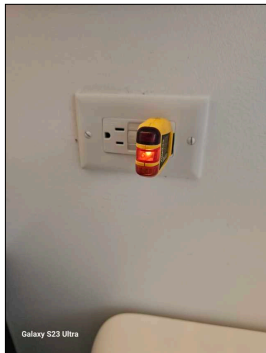
8.3. The GFCI outlet at multiple areas of the home did not trip when tested. Repair or replace.

D.t hallway bathroom

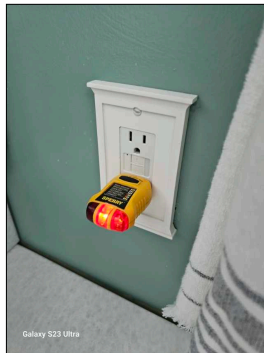
D.t master

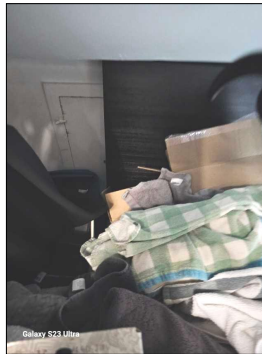
1.1. The main water shutoff valve is located under the basement stairs. However, due to homeowners belongings we could not fully access the shut off valve at the time of inspection. Recommend having sellers remove debris and demonstrate the functionality of the valve.

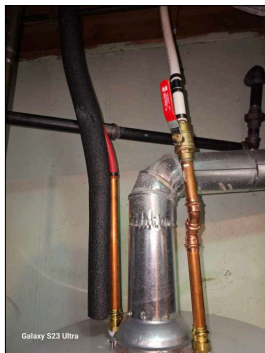
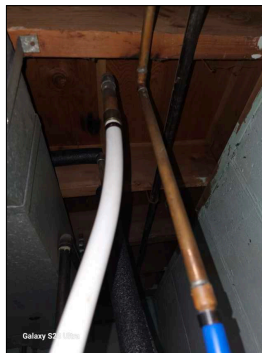
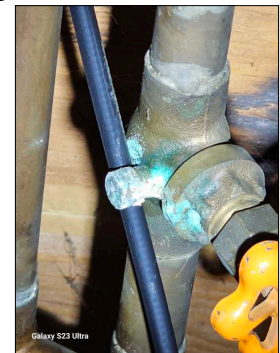
2.1. Rust/corrosion present on the water supply lines at the basement. Monitor and repair/replace if condition worsens.

2.2. Water lines are not properly supported in the basement. Correction needed to help prevent damage.

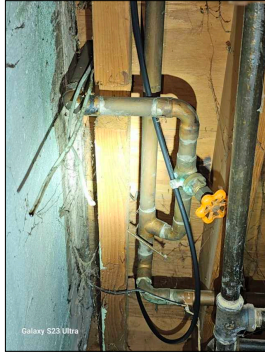
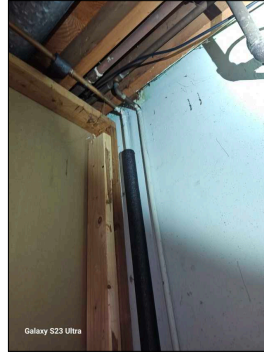
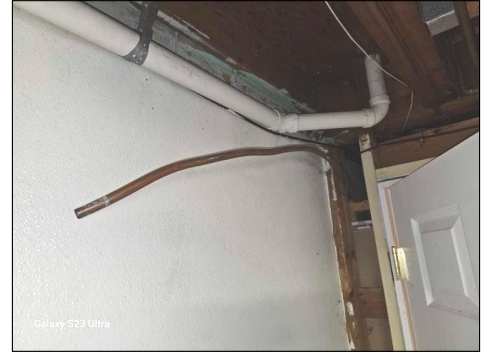
Cut/no longer in use supply lines noted in the basement. Recommend properly supporting or removing the line as needed.

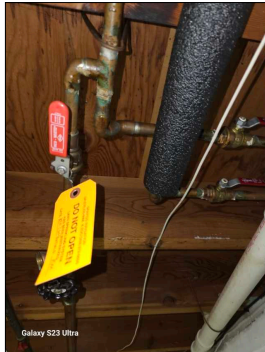
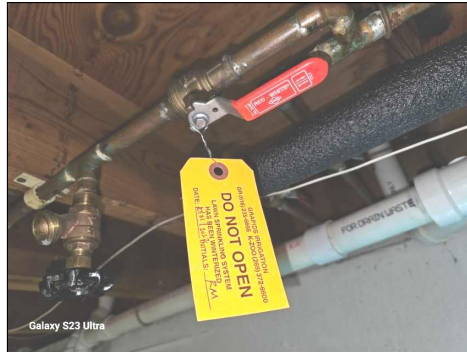
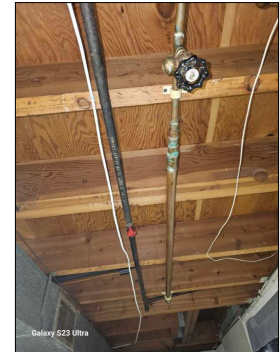
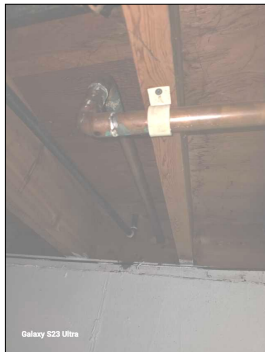
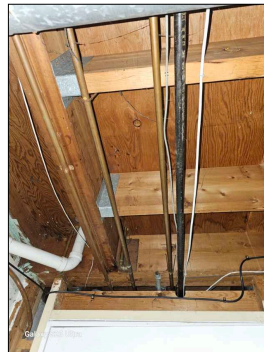
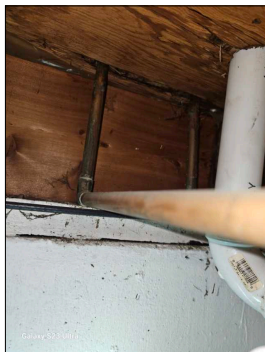
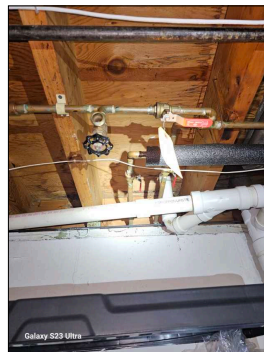
2.3. Signs of past leaks noted at one or more areas of the basement. This is common for homes of similar age and no active leaks were noted at the time of inspection. Recommend monitoring and repairing as needed.

Past leaks noted

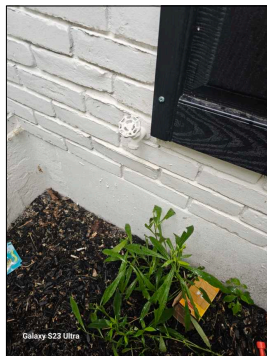
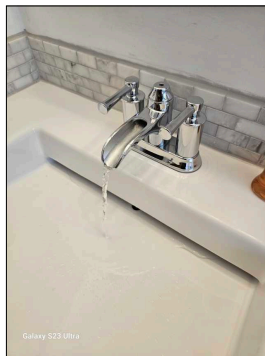
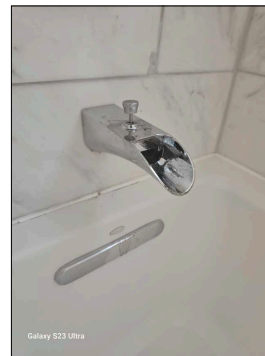
3.1. The stopper at the hallway bathroom sink did not function properly. Repair/replace as necessary. The fixture drained as intended.

3.2. An exterior faucet at the front of the home was operable, but had no water flow. Per company policy, we don't turn on interior shut off valves and recommend asking the seller to demonstrate their functionality.

3.3. The tub spout is loose and should be secured to help prevent damage to the pipe.

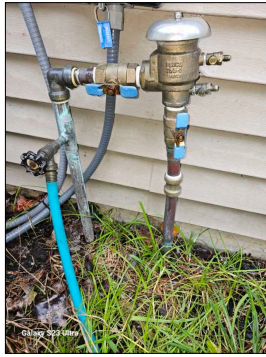
Pressure vacuum breaker-lawn irrigation system-was not operational at the time of inspection

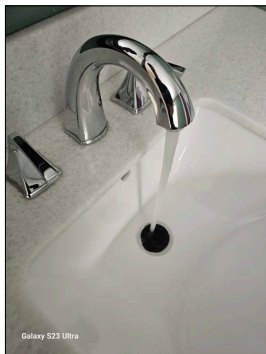
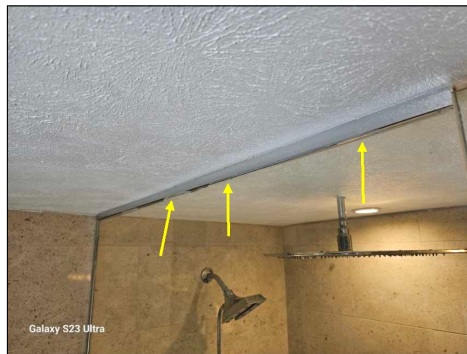
4.4. The shower door at the master bathroom is improperly secured. A repair is needed.

Loose pane glass noted at the master bathroom shower. This should be properly secured/repared.

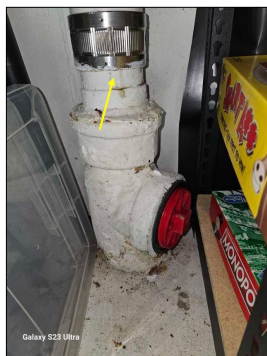
5.2. Signs of past leaks noted at one or more areas of the basement. No active leaks were noted at the time of inspection. Recommend monitoring and repairing as needed.

Signs of past leaks noted at the main plumbing stack.

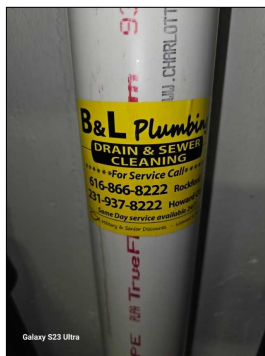
Previous sewer cleaning noted

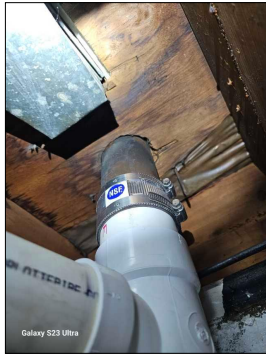
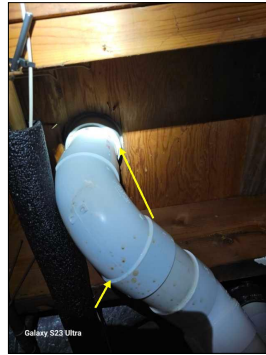
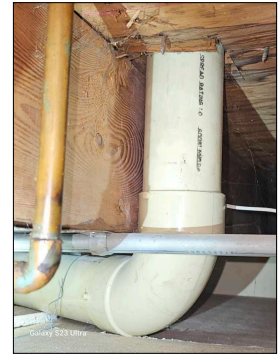
Past leaks noted at the toilet drain. No active leaks were noted at the time of inspection.

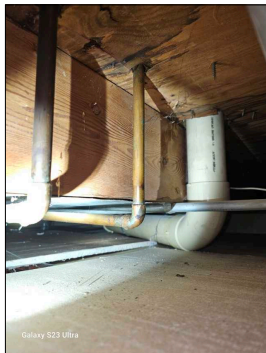
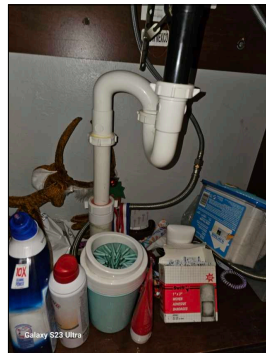
5.3. The drain pipe(s) has an S-trap installed and should be changed to a P-trap with an "Auto-vent" at multiple areas. An S-trap can sometimes gurgle (struggling for air when draining water). Also, if not used for long periods, an S-trap can allow the water in the trap to evaporate, which could cause sewer odors to leak out. An S-trap can sometimes lose the water in the trap through a pressure drop in the sewage system (outside the house). Although this is commonly found in homes of similar age, this is not considered up to current standard.

S-trap half bath

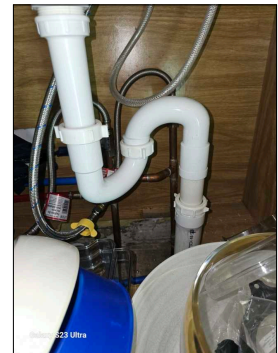
S-trap utility sink

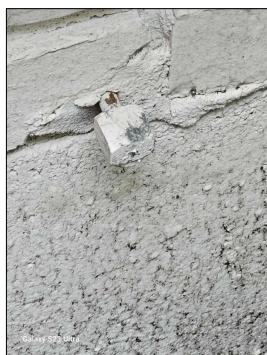
Old burp valve noted exterior front side.  
Not in use

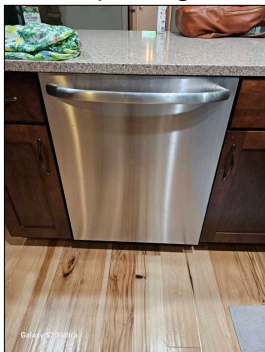
1.1. Unit is loose in the opening and should be secured.

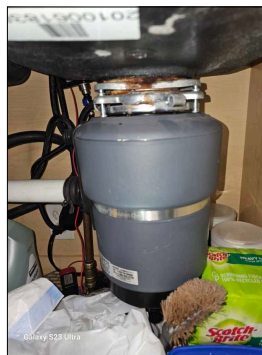
2.1. Unit is corroded and shows signs of past leaks. Recommend monitoring and repairing as necessary.

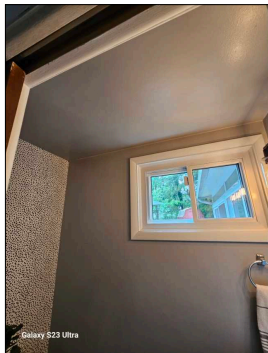
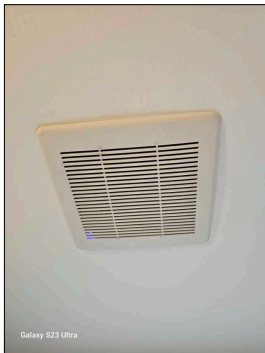
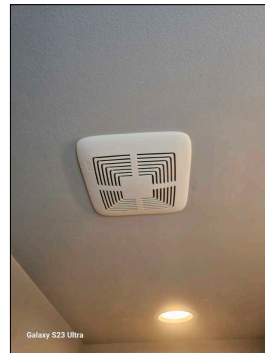
1.2. One exhaust fan vents to the attic and should be extended to the exterior.

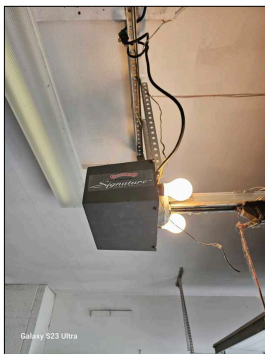
2.1. Missing light cover noted.

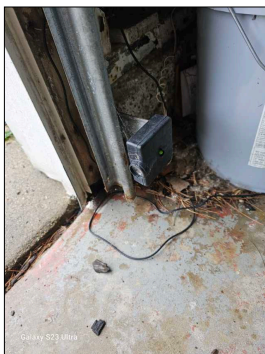
3.1. Motion sensors are not functional and should be serviced.

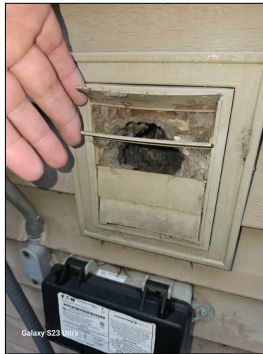
5.2. The dryer vent terminates within close proximity to the exterior condensing unit. Recommend relocated the termination of the dryer vent as necessary.

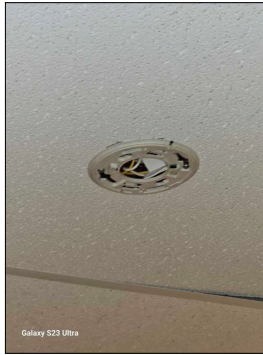
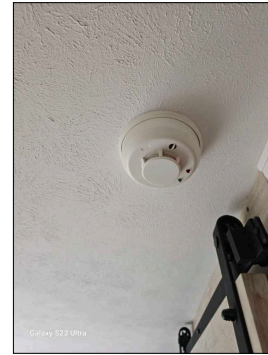
6.2. Working smoke detectors were not found at all areas of the home.

6.3. The smoke detectors are older and should be upgraded. Smoke detectors should be upgraded every 6-8 years.

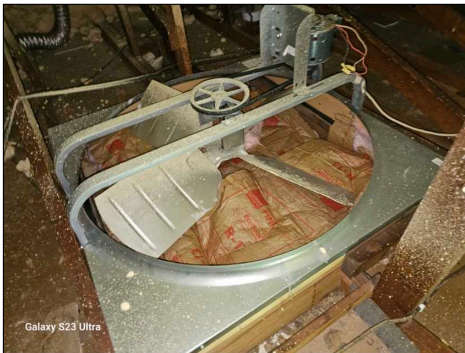
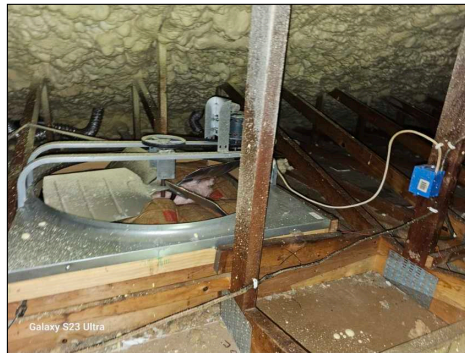
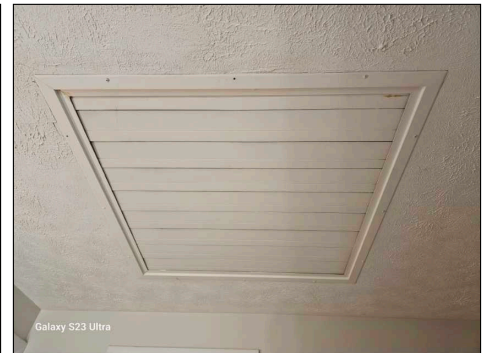
7.1. The whole house attic vent fan was blocked with insulation and was not functional at the time of inspection.
